APPENDIX A

Supplemental Facility Monitoring Data

Bedrock Groundwater Mapping
Surface Drainage Inspection
ENVIRON Inspection Report

Title:	Site Photographs	Date: 10/27/2010
Site:	ESOI Otter Creek	Project-No.: 02-6471M14B
Client:	Envirosafe Services of Ohio, Inc.	ENVIRON

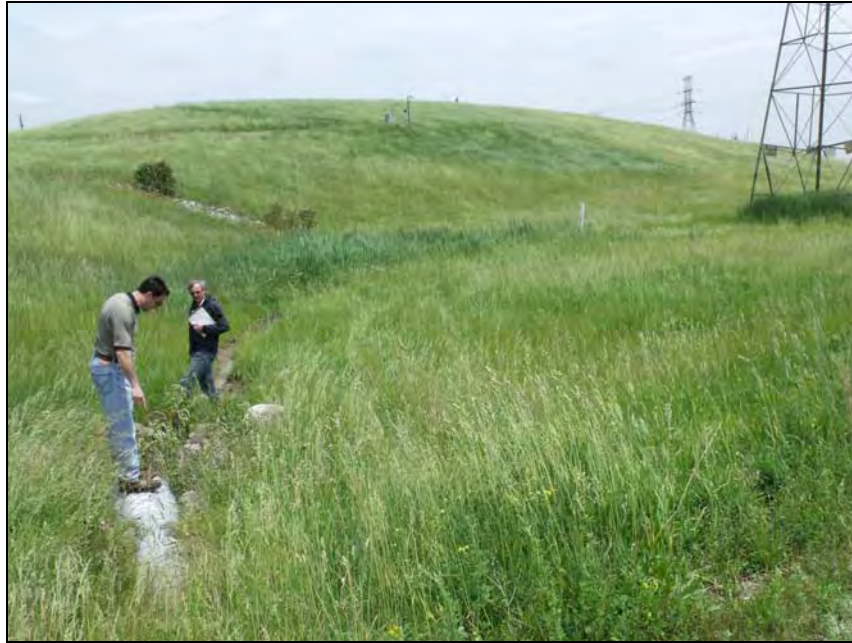
Photo 7: Drainage Ditch – SE corner of SWMU 6

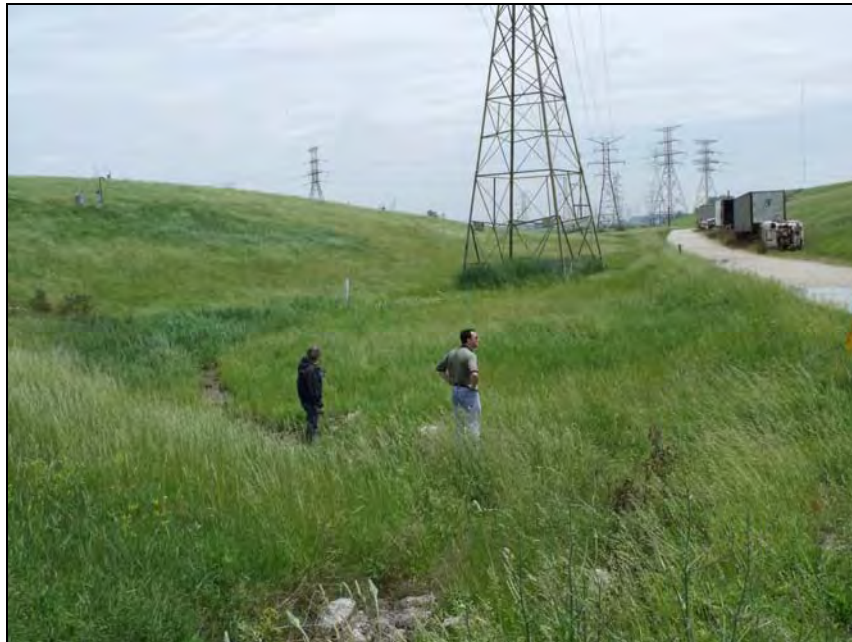
Photo 8: Drainage Ditch – SE corner of SWMU 6

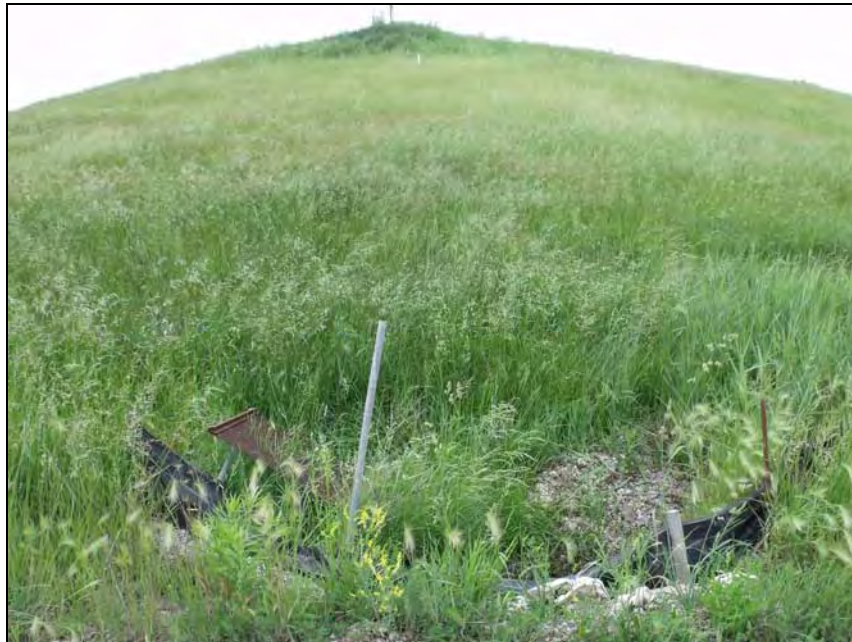
Photo 16: SWMU 6 – northeast corner

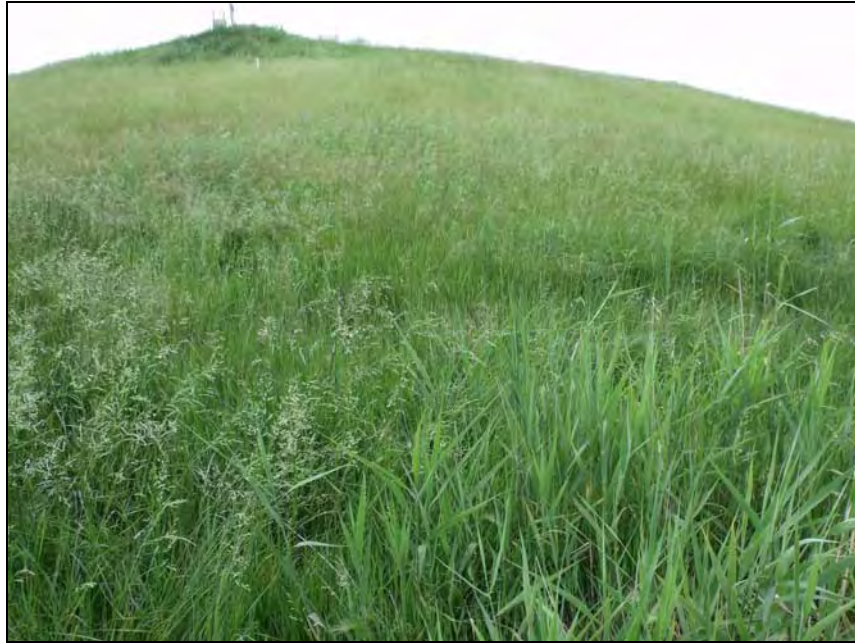
Photo 17: SWMU 6 – northeast corner

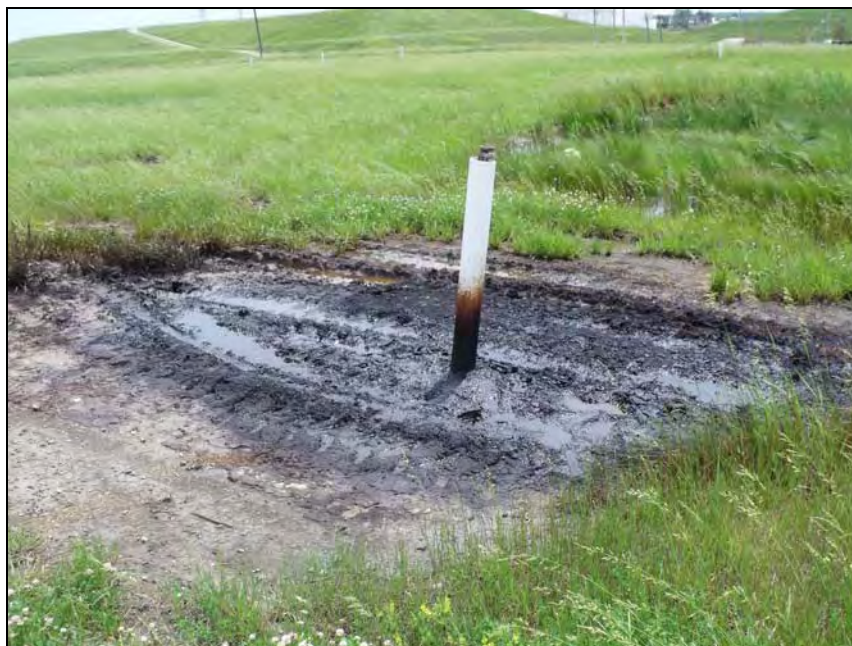
Photo 22: SWMU 9 – stained vent pipe.

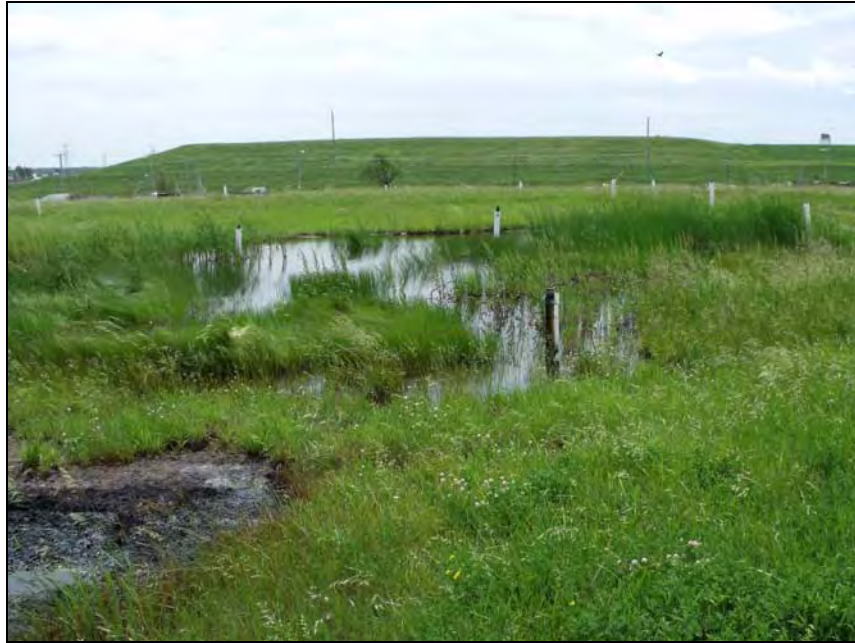
Photo 23: SWMU 9 – stained area and ponding.

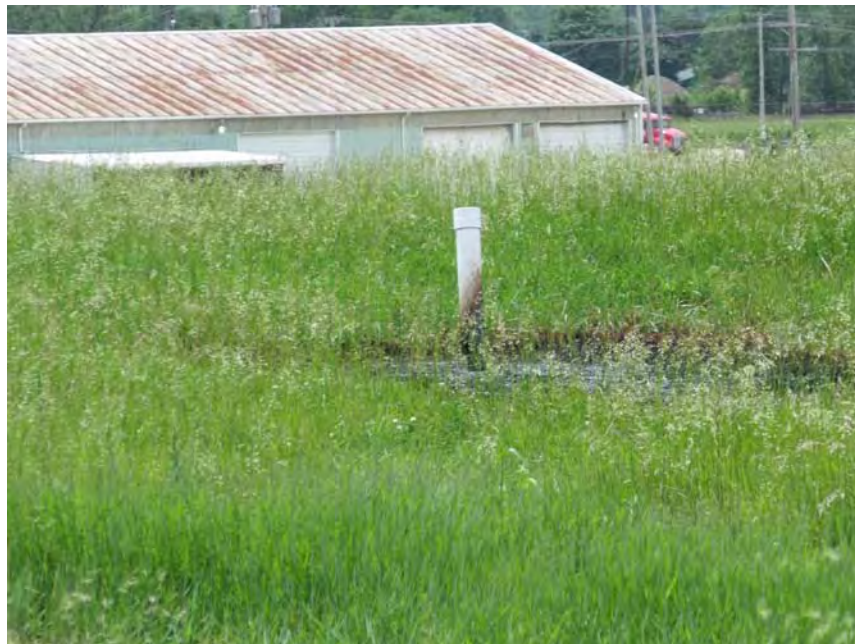
Photo 24: SWMU 9 – stained vent pipe.

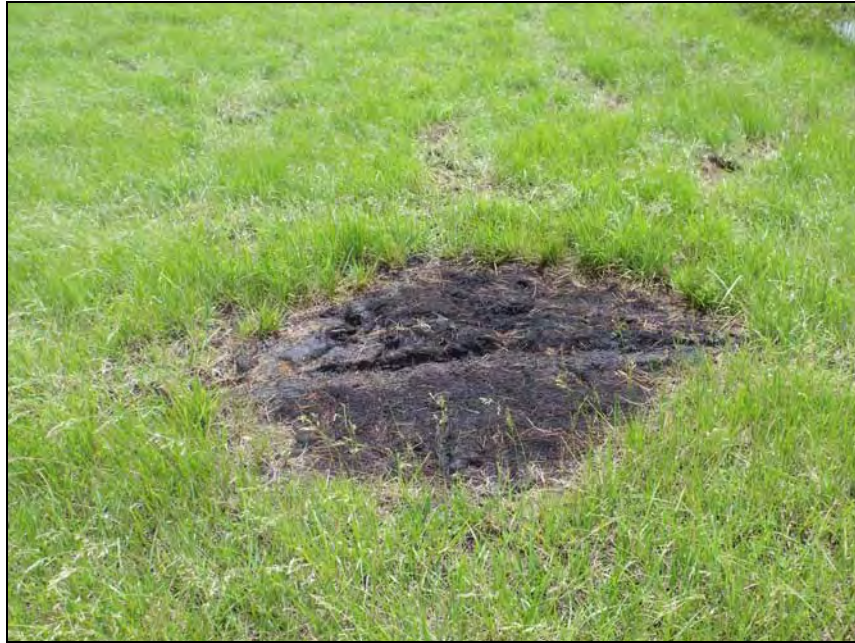
Photo 25: SWMU 9 – stained area.

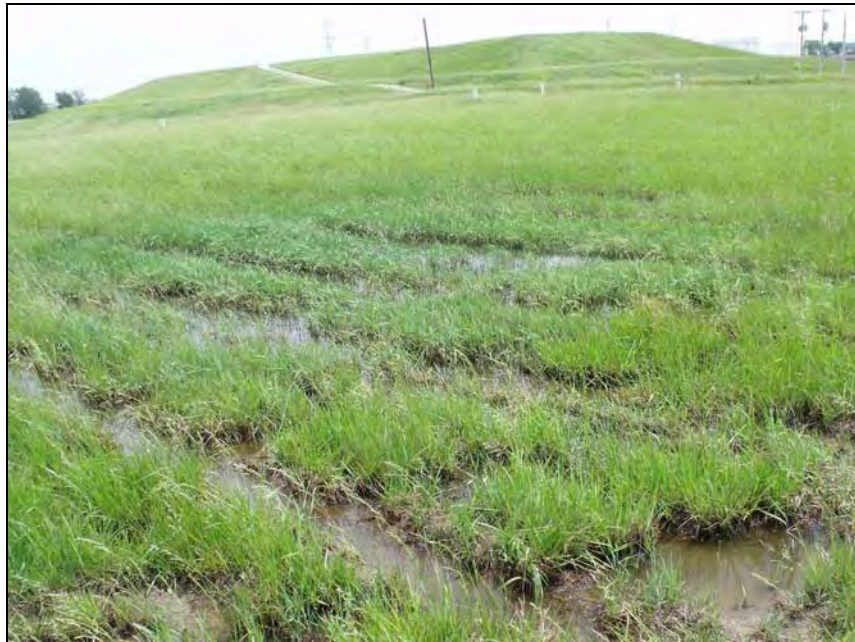
Photo 26: SWMU 9 – standing water

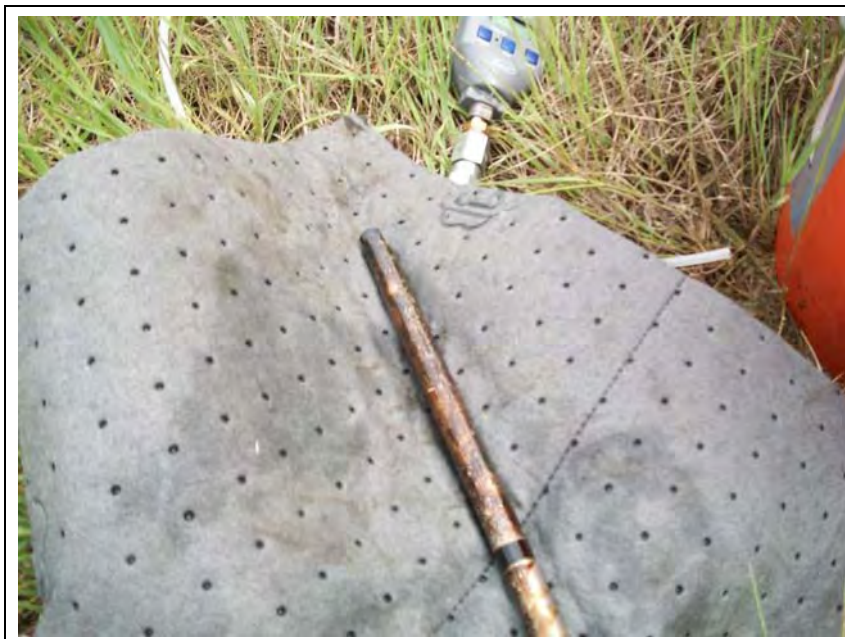
Photo 30: SWMU 8 – O/I probe tip after measurement at TLW-205.

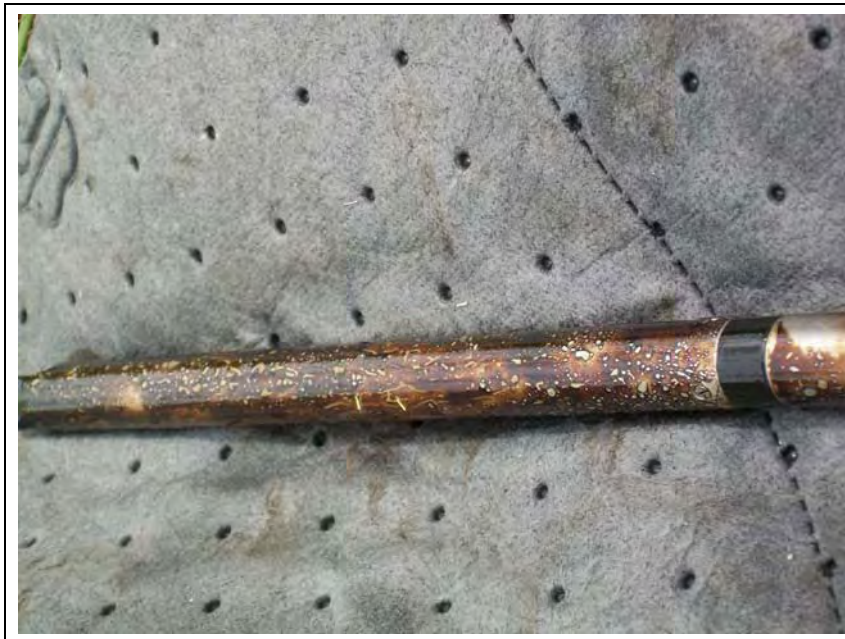
Photo 31: SWMU 8 – O/I probe tip after measurement at TLW-205.

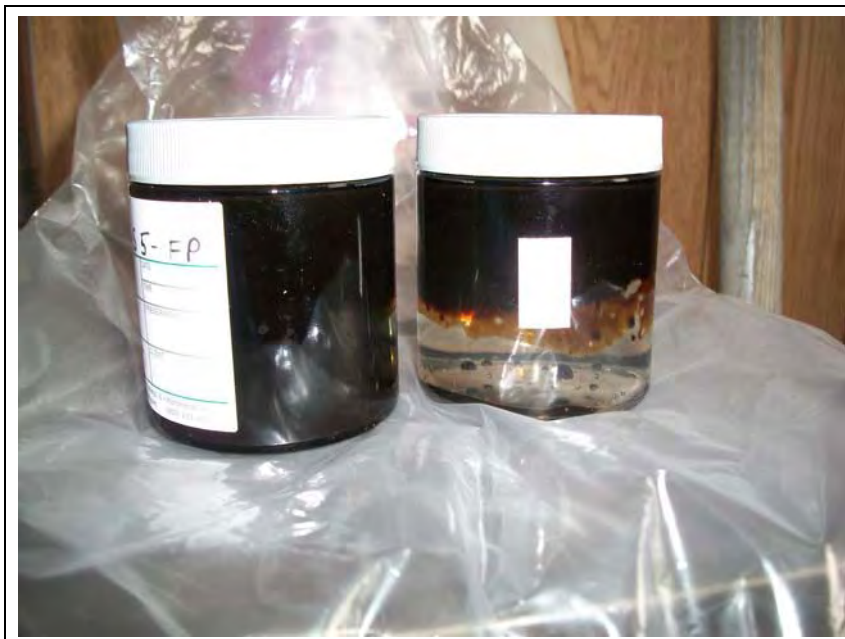
Additionally, a confirmatory NAPL sample was collected from T20S(5) and analyzed for specific gravity and viscosity. This location was selected for a sample as the visible characteristics of the NAPL appeared different from those noted during the RFI. Sample results from T20S(5) are summarized on Table 4a. Viscosity results are similar between the two sampling events. For reference, similar measurements collected during the RFI are also provided Table 4b.

Photo 32: NAPL sample collected from T20S(5).
