## **APPENDIX A**

### **Supplemental Facility Monitoring Data**

# ENVIROSAFE SERVICES OF OHIO, INC.

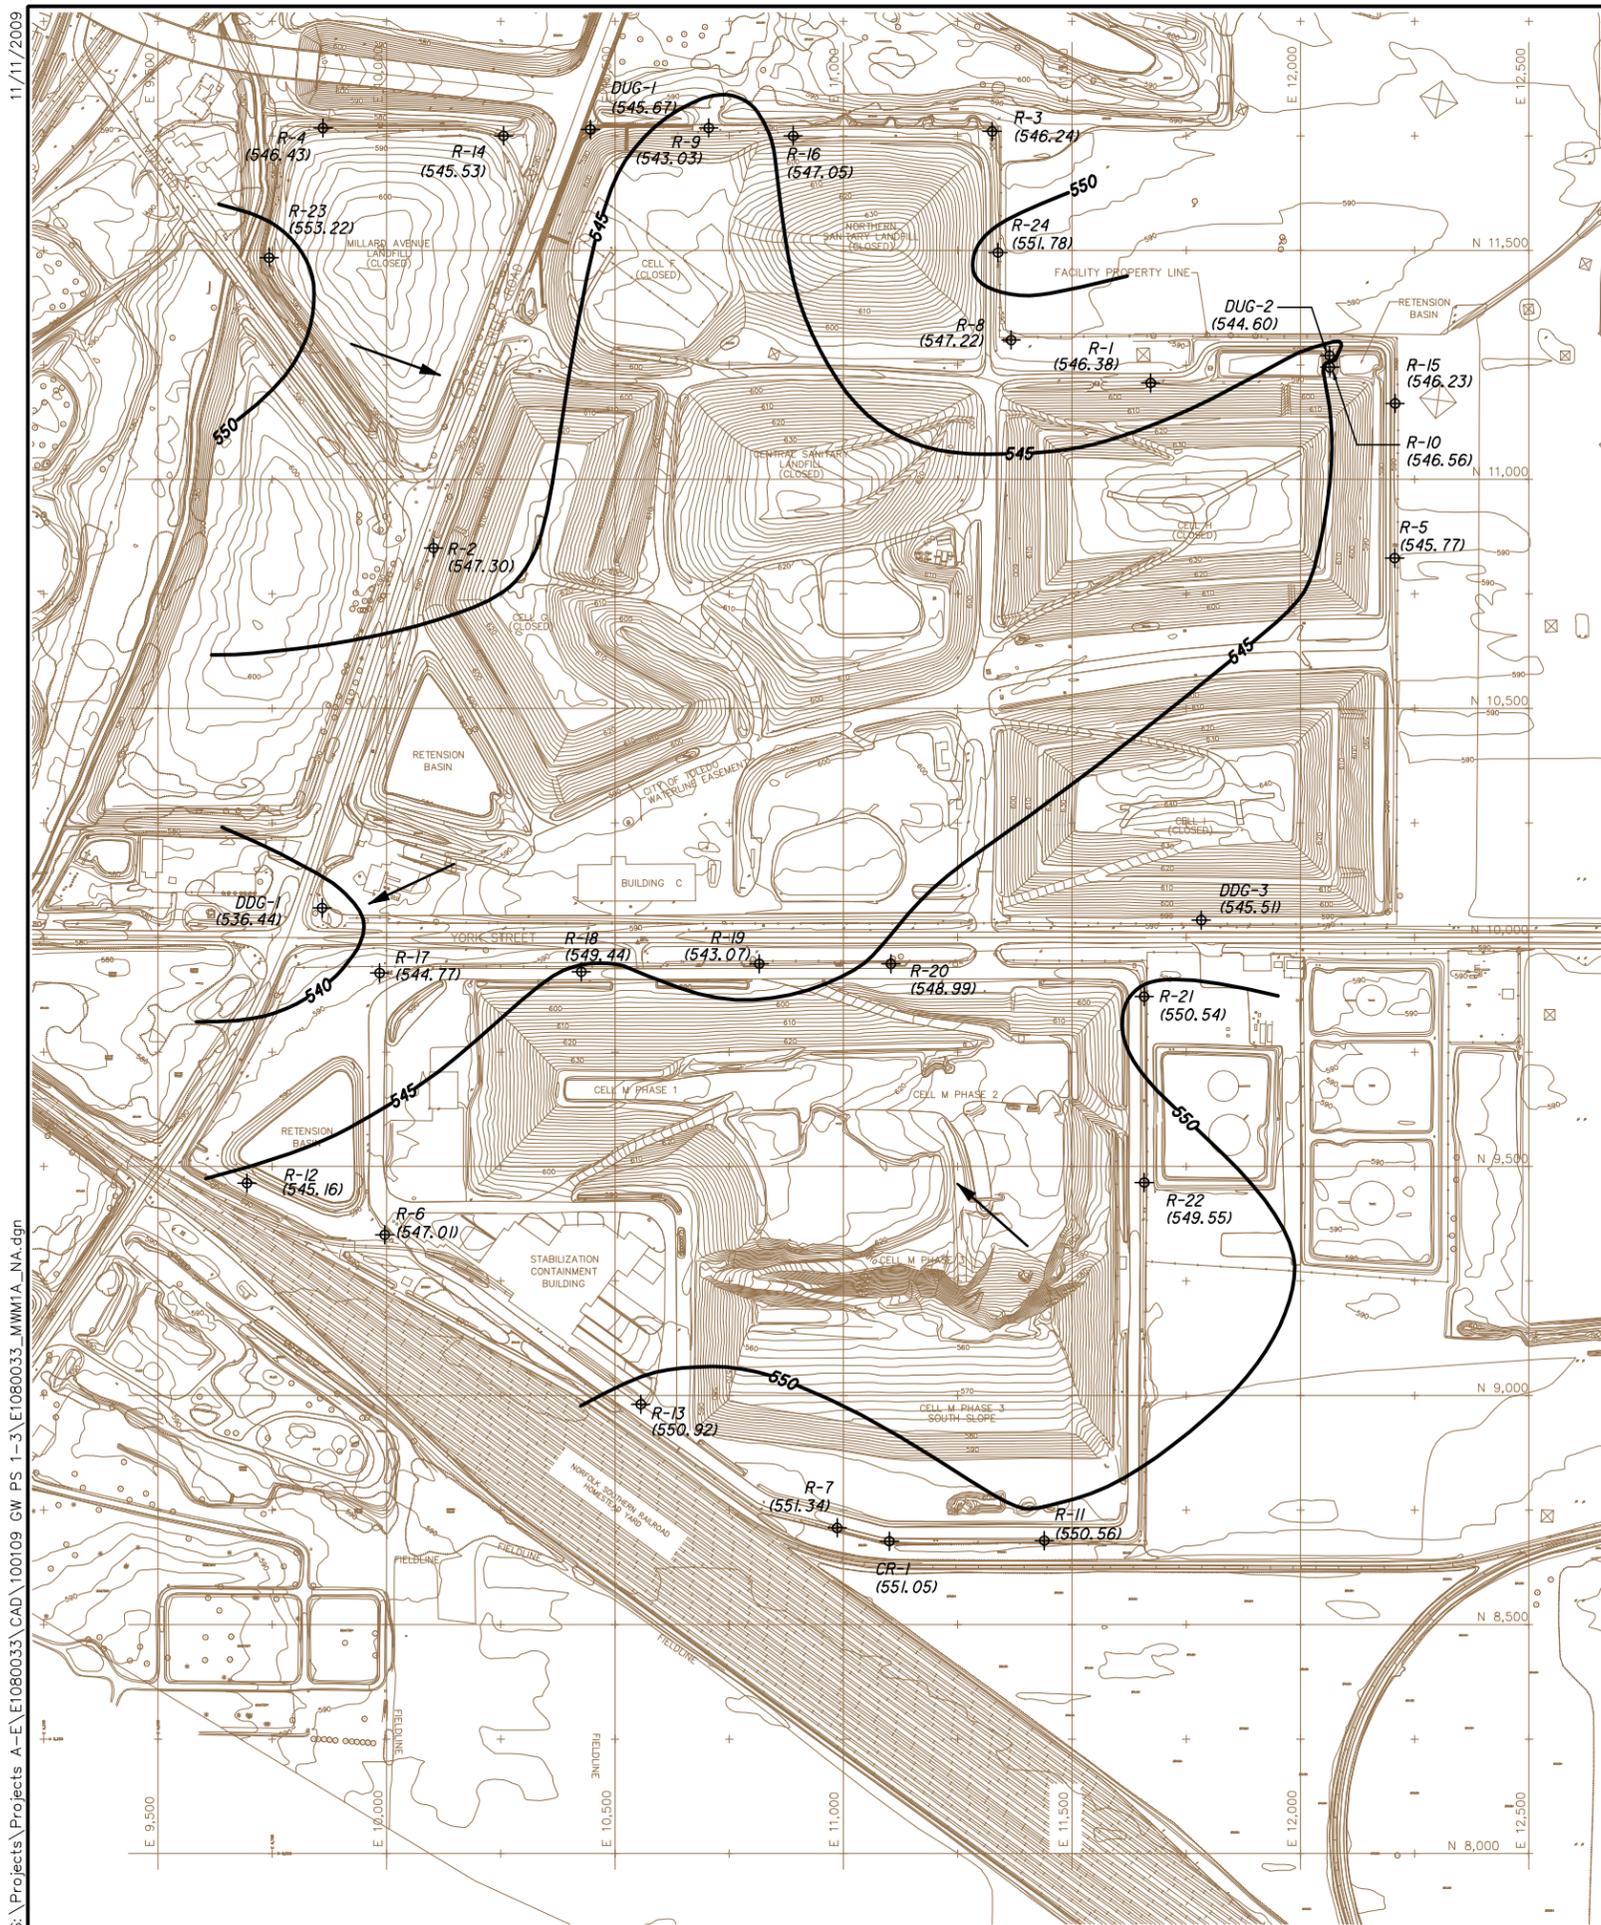
BEDROCK MONITORING WELLS			
OCTOBER 1, 2009			
MONITORING WELL	TOP OF CASING (FEET MSL)	WATER LEVEL (FEET)	WATER LEVEL ELEVATION (FEET MSL)
CR-1	594.65	43.60	551.05
DDG-1	587.41	50.97	536.44
DDG-3	593.71	48.20	545.51
DUG-1	586.59	40.92	545.67
DUG-2	595.76	51.16	544.60
R-1	596.71	50.33	546.38
R-2	594.12	46.82	547.30
R-3	593.96	47.72	546.24
R-4	588.33	41.90	546.43
R-5	593.20	47.43	545.77
R-6	595.30	48.29	547.01
R-7	596.28	44.94	551.34
R-8	594.44	47.22	547.22
R-9	591.40	48.37	543.03
R-10	596.68	50.12	546.56
R-11	596.08	45.52	550.56
R-12	594.64	49.48	545.16
R-13	595.61	44.69	550.92
R-14	586.82	41.29	545.53
R-15	592.13	45.90	546.23
R-16	598.03	50.98	547.05
R-17	592.32	47.55	544.77
R-18	591.56	42.12	549.44
R-19	595.38	52.31	543.07
R-20	595.64	46.65	548.99
R-21	594.34	43.80	550.54
R-22	595.66	46.11	549.55
R-23	591.32	38.10	553.22
R-24	592.40	40.62	551.78

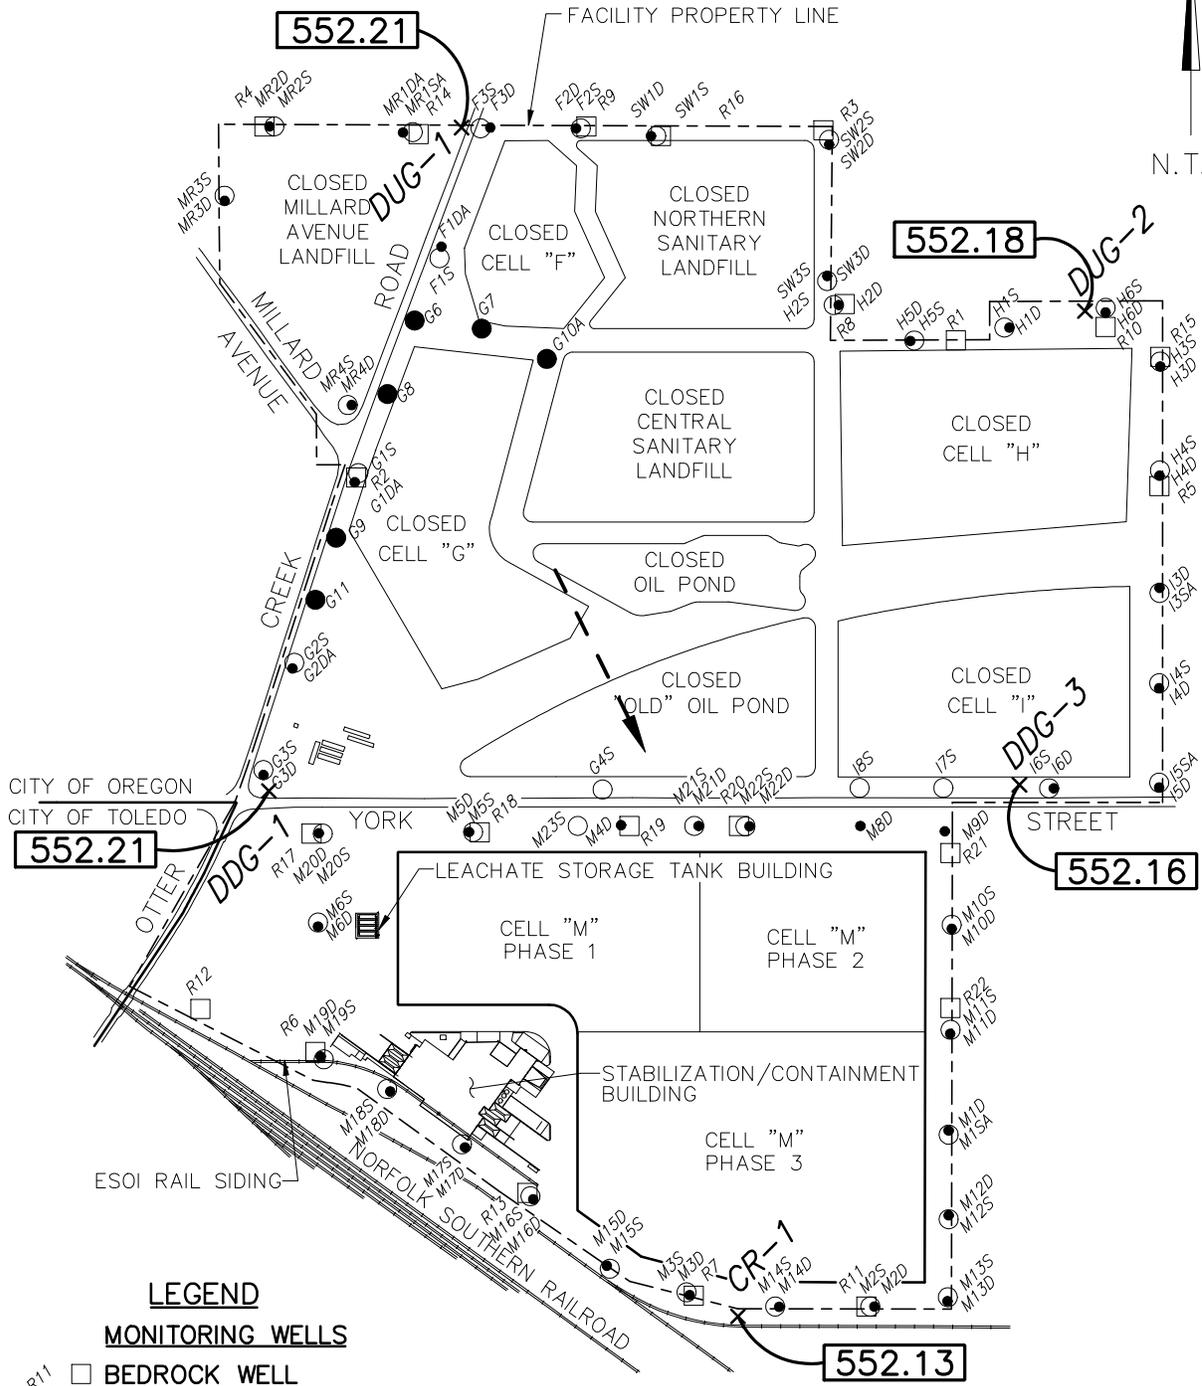
## OTTER CREEK FACILITY POTENTIOMETRIC SURFACE MAP SEPTEMBER 2, 2009

- LEGEND**
- MONITORING WELLS**
- BEDROCK WELL
  - DEEP WELL SAND
  - DEEP WELL TILL
  - SHALLOW WELL
  - ⊗ CHART RECORDER WELL
  - 552- EQUIPOTENTIAL CONTOUR LINE
  - ▲ ESTIMATED FLOW DIRECTION.
- POTENTIOMETRIC SURFACE EXHIBITS VERY LITTLE RELIEF.

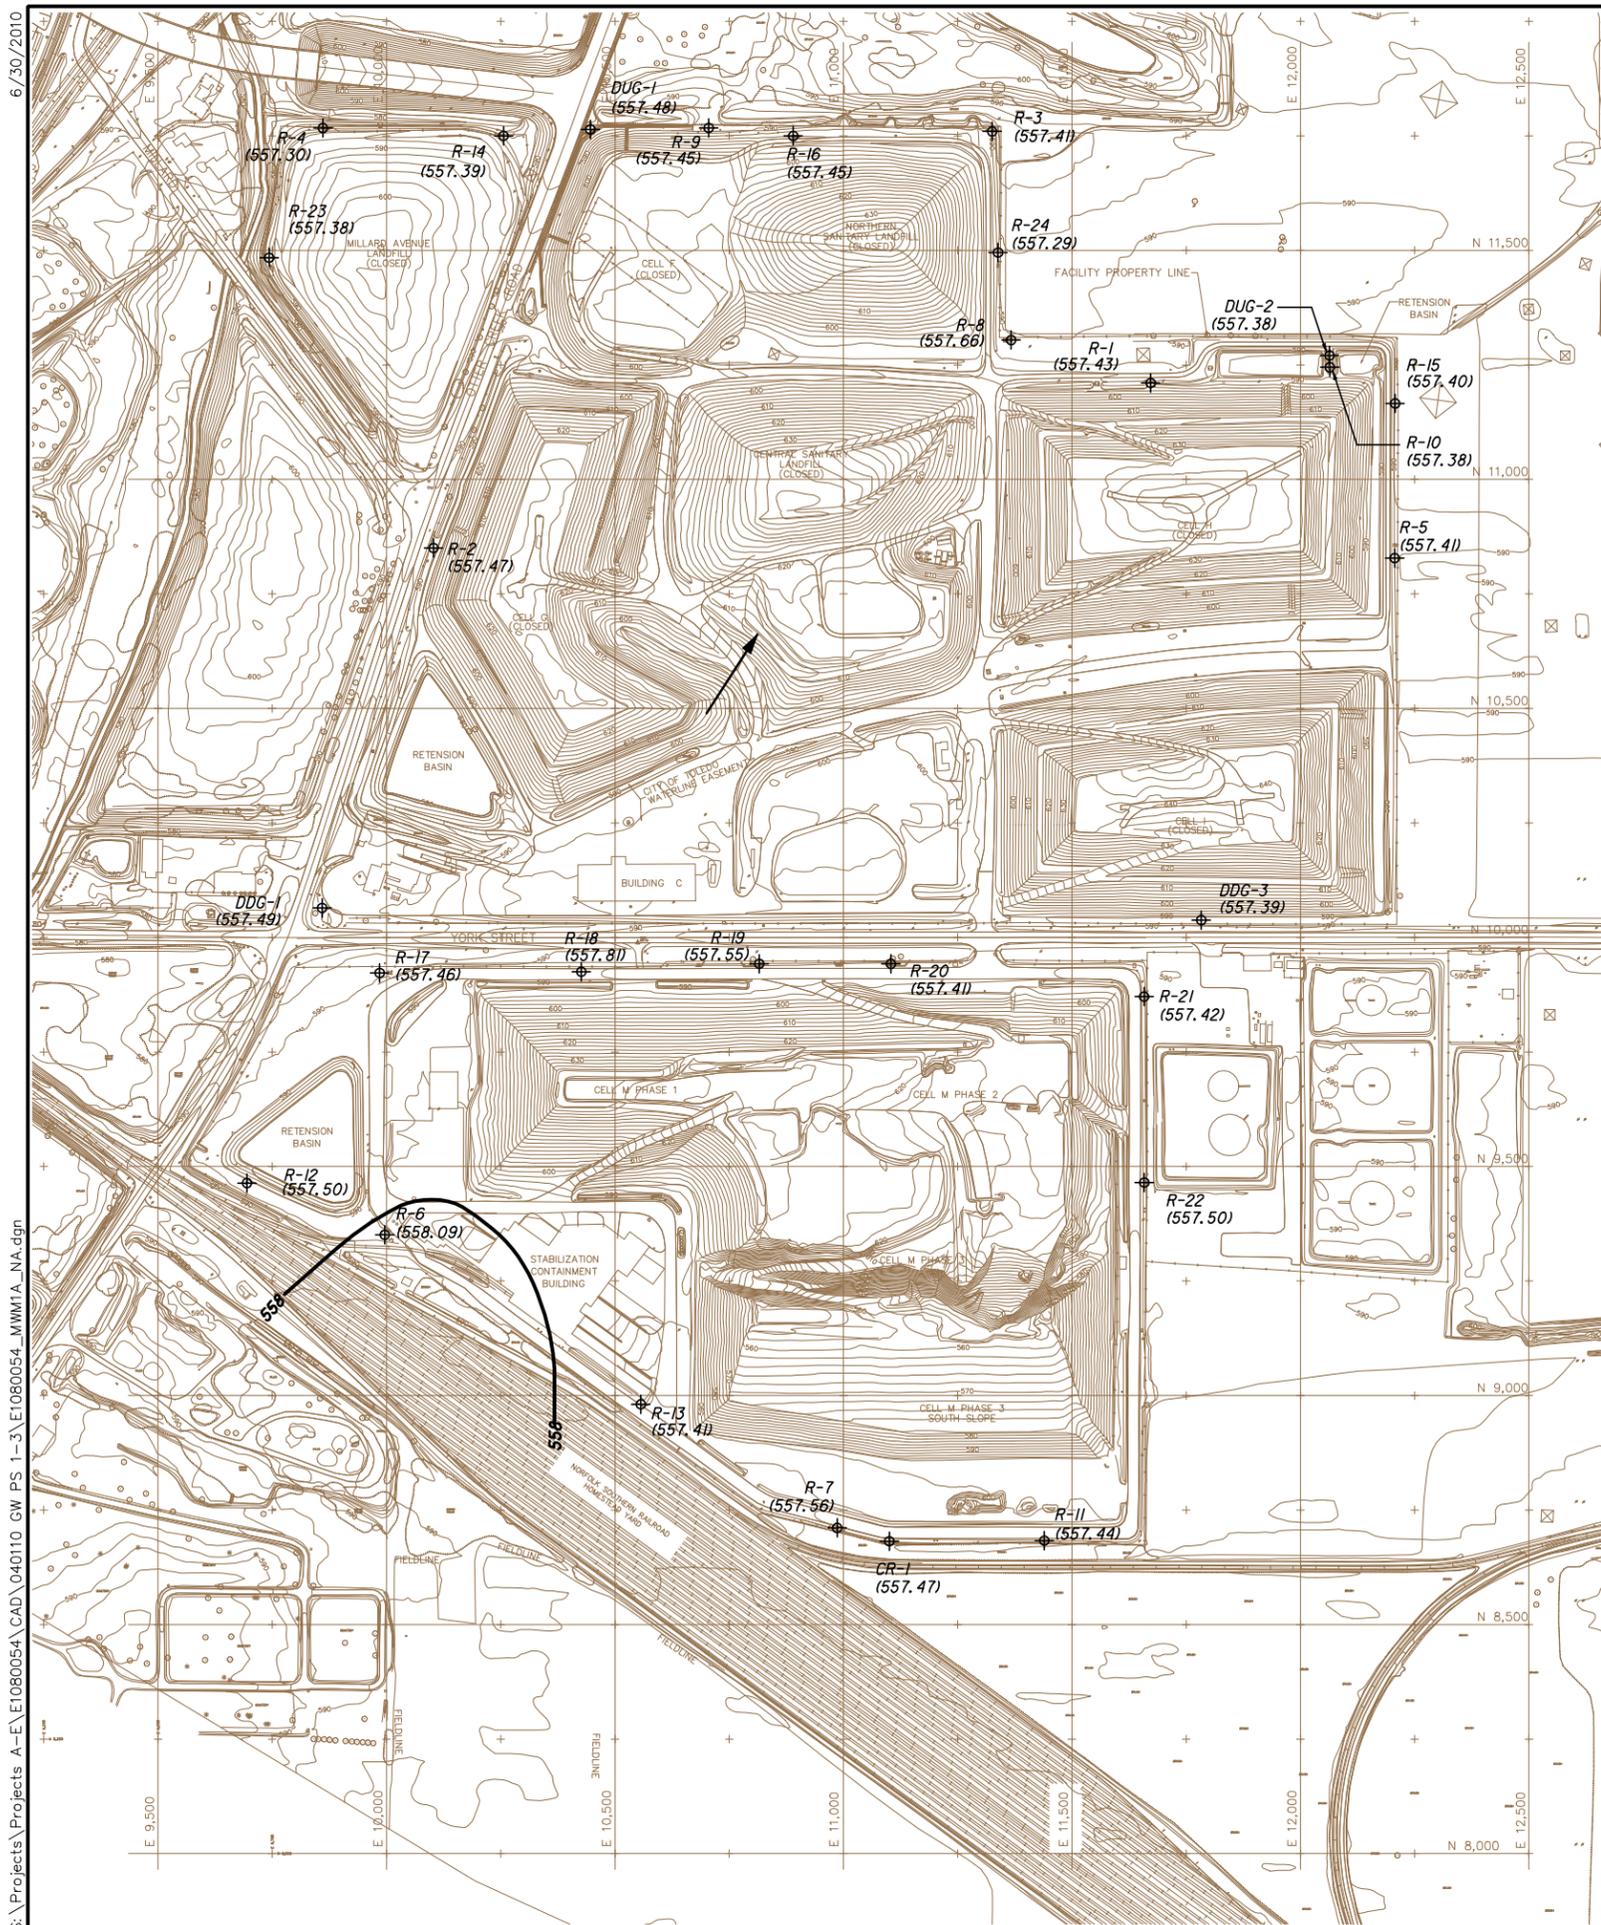
BEDROCK MONITORING WELLS			
APRIL 1, 2010			
MONITORING WELL	TOP OF CASING (FEET MSL)	WATER LEVEL (FEET)	WATER LEVEL ELEVATION (FEET MSL)
CR-1	594.65	37.18	557.47
DDG-1	587.41	29.92	557.49
DDG-3	593.71	36.32	557.39
DUG-1	586.59	29.11	557.48
DUG-2	595.76	38.38	557.38
R-1	596.71	39.28	557.43
R-2	594.12	36.65	557.47
R-3	593.96	36.55	557.41
R-4	588.33	31.03	557.30
R-5	593.20	35.79	557.41
R-6	595.30	37.21	558.09
R-7	596.28	38.72	557.56
R-8	594.44	36.78	557.66
R-9	591.40	33.95	557.45
R-10	596.68	39.30	557.38
R-11	596.08	38.64	557.44
R-12	594.64	37.14	557.50
R-13	595.61	38.20	557.41
R-14	586.82	29.43	557.39
R-15	592.13	34.73	557.40
R-16	598.03	40.58	557.45
R-17	592.32	34.86	557.46
R-18	591.56	33.75	557.81
R-19	595.38	37.83	557.55
R-20	595.64	38.23	557.41
R-21	594.34	36.92	557.42
R-22	595.66	38.16	557.50
R-23	591.32	33.94	557.38
R-24	592.40	35.11	557.29

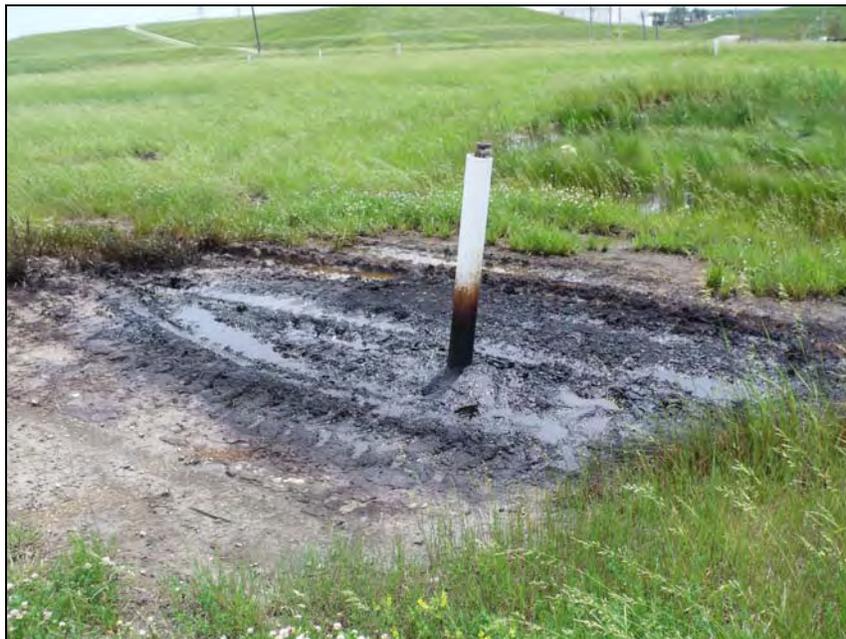
**Photo 22:** SWMU 9 – stained vent pipe.

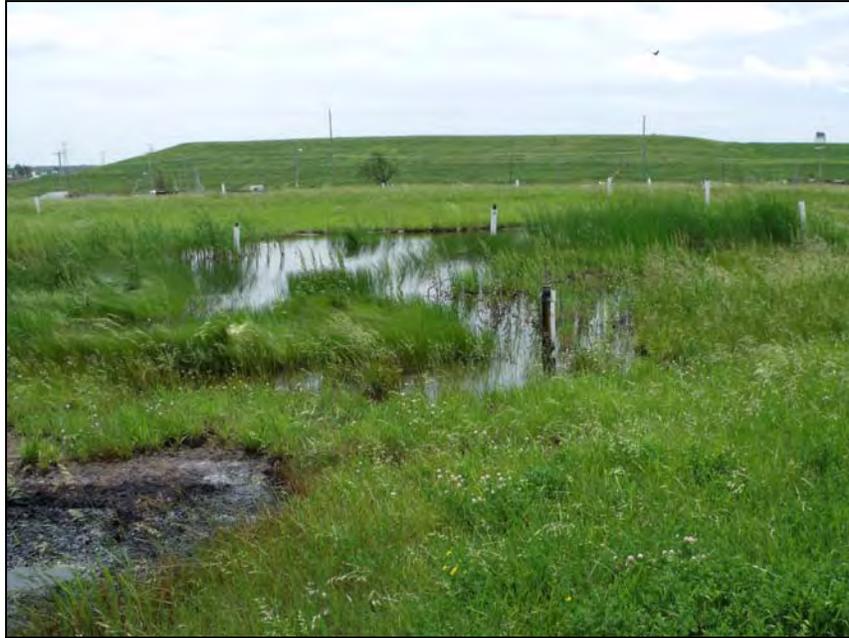
**Photo 23:** SWMU 9 – stained area and ponding.

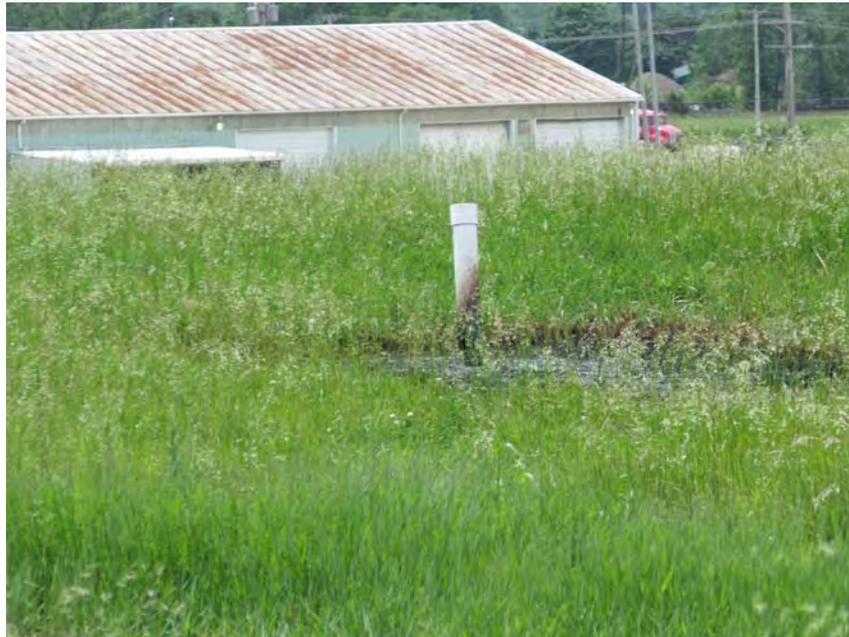
**Photo 24:** SWMU 9 – stained vent pipe.

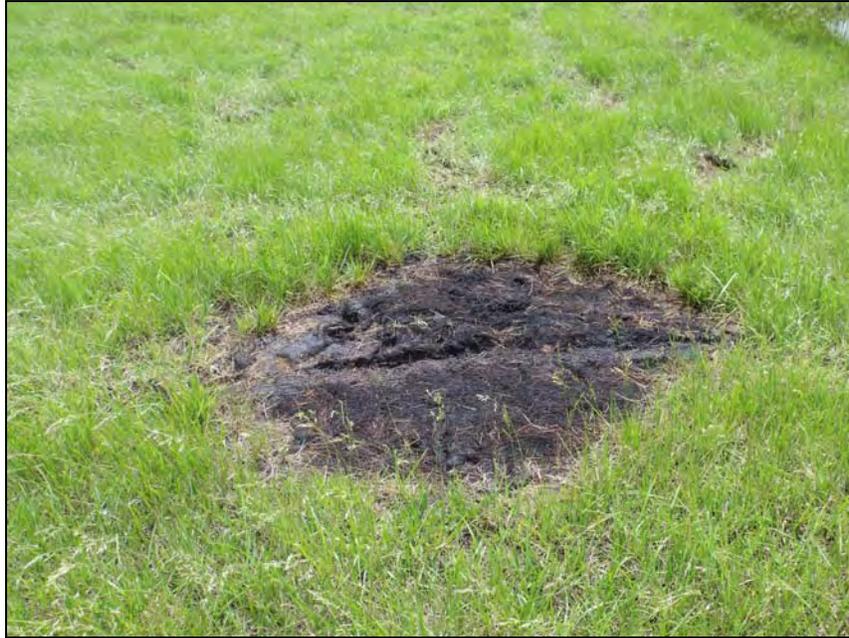
**Photo 25:** SWMU 9 – stained area.

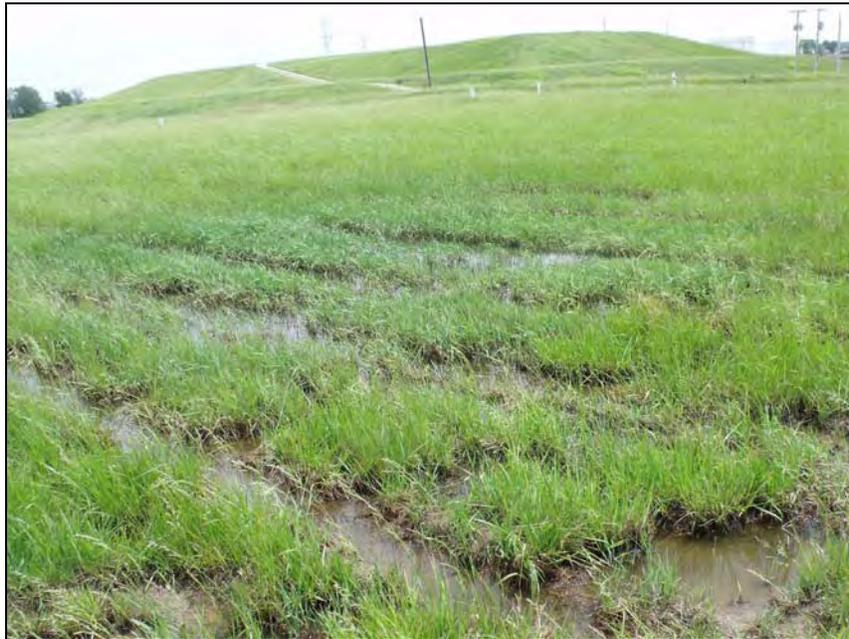
**Photo 26:** SWMU 9 – standing water

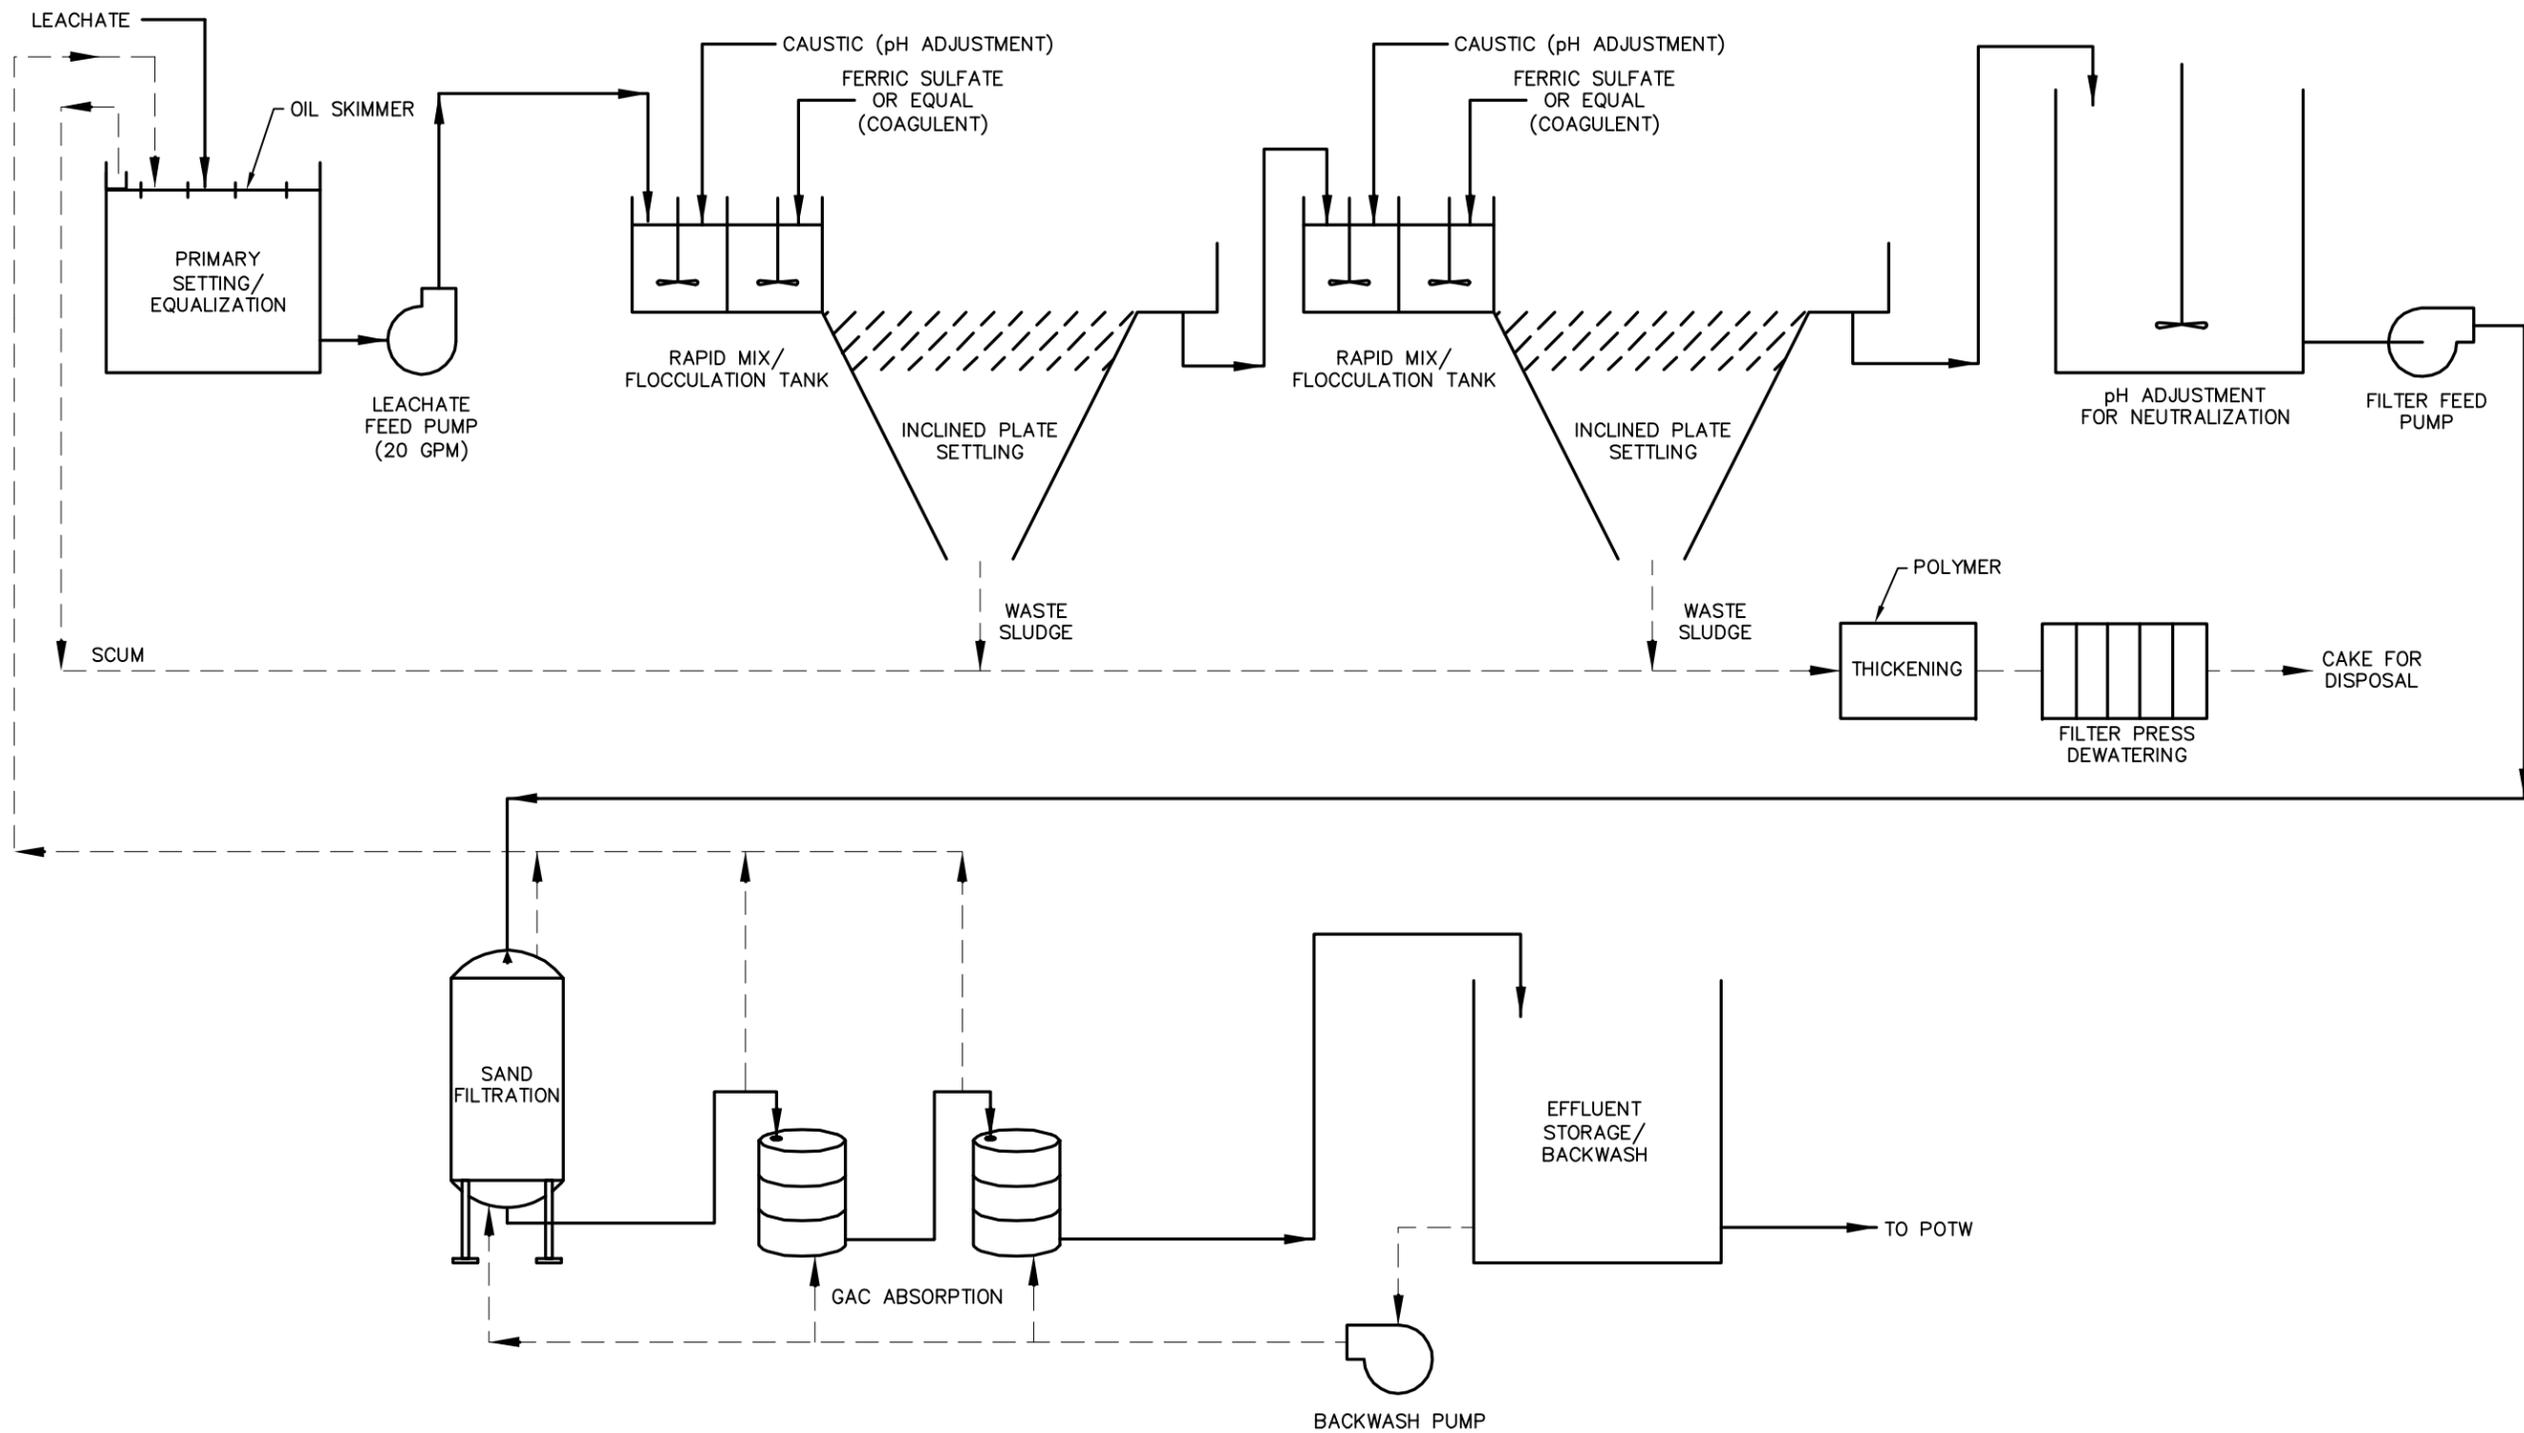
The pretreatment system would occupy an area of approximately 50 x 50 square-foot space. A process flow diagram of the conceptual treatment system is included as Figure 1.

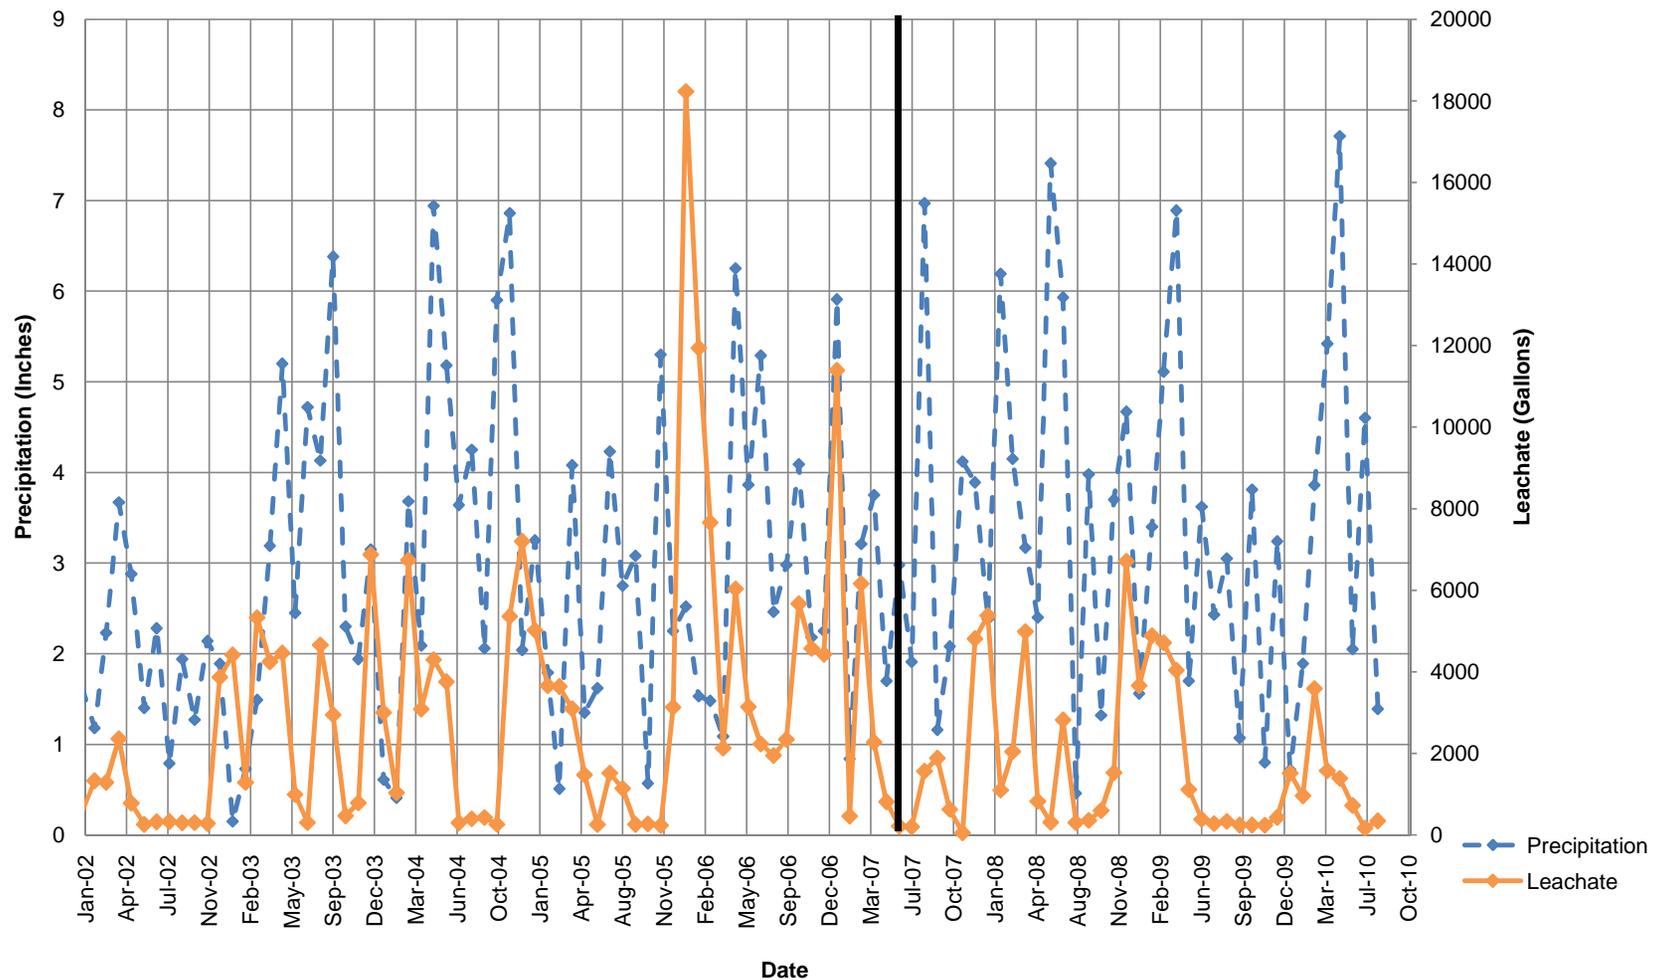
## Precipitation vs. Leachate Recovery at SWMU 1 ESOI Otter Creek Facility, Oregon, Ohio

Note: In 2006, torrential rain events and further subsidence caused excessive ponding and a significant water flow path around the leachate extraction manhole. It is believed that storm water directly entered the collection system through the manhole and is the reason for the skewed amount of leachate. The area was regraded and the manhole was repaired to prevent stormwater from entering the manhole., which is shown as a black vertical line in the graph.

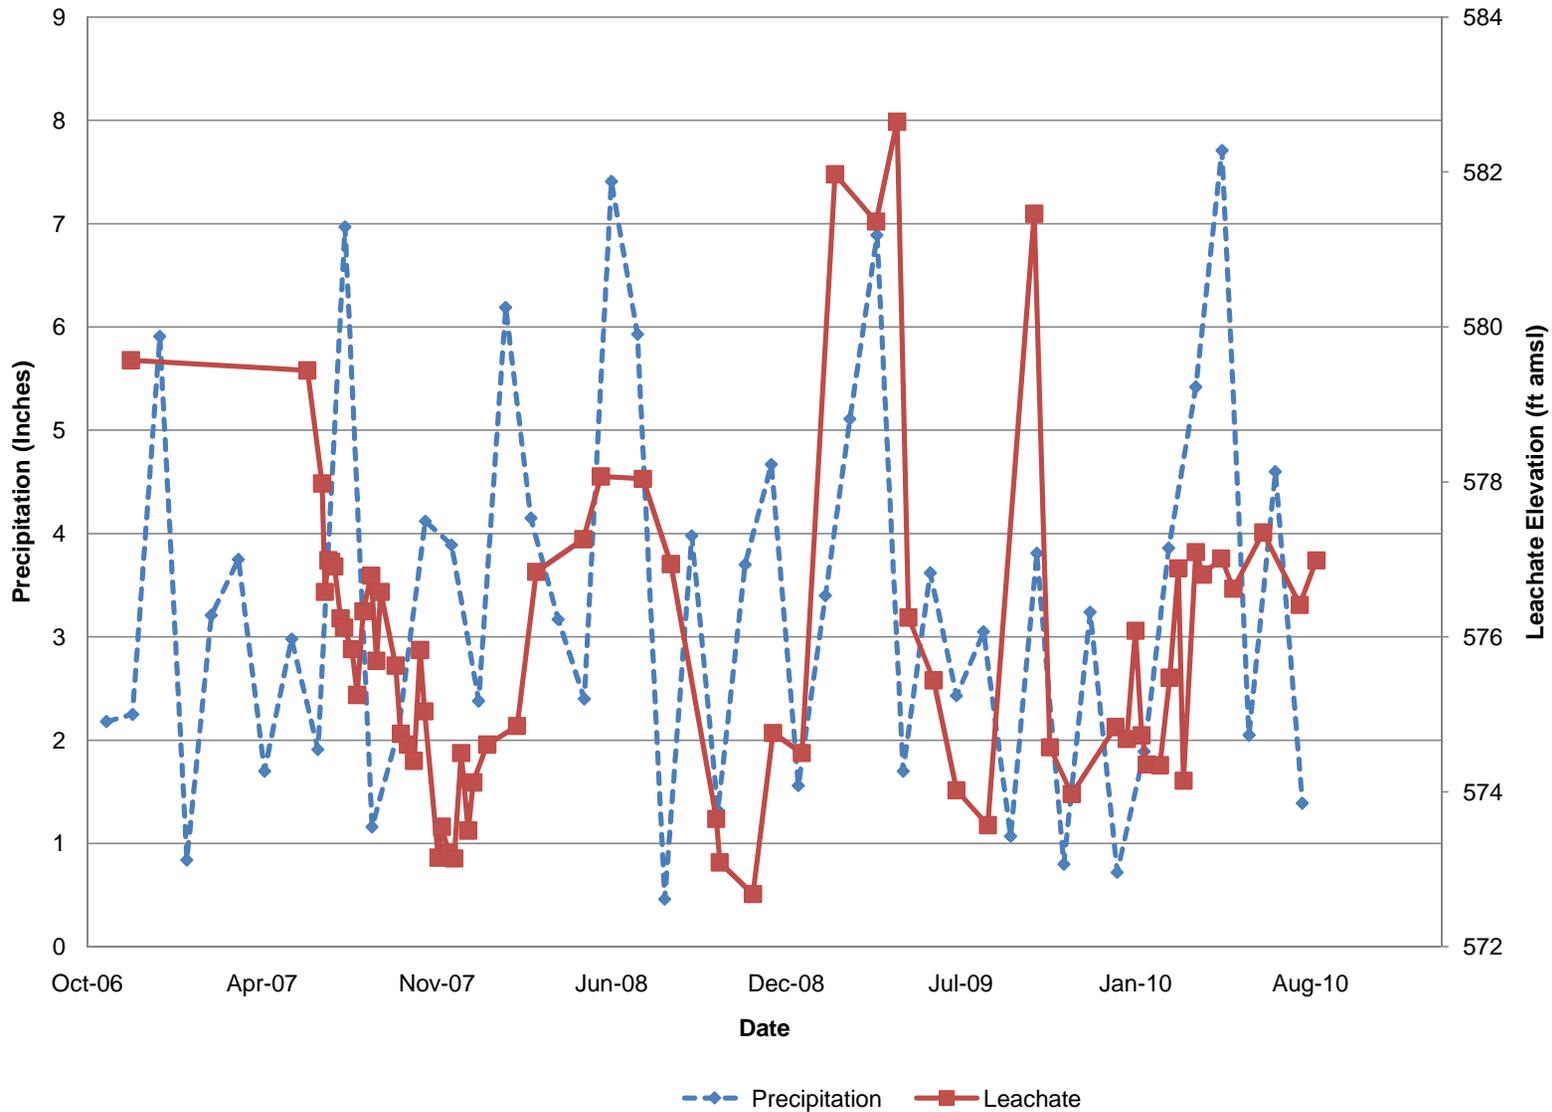
## Precipitation vs. Leachate Levels at SWMU 5 - Central ESOI Otter Creek Facility, Oregon, Ohio

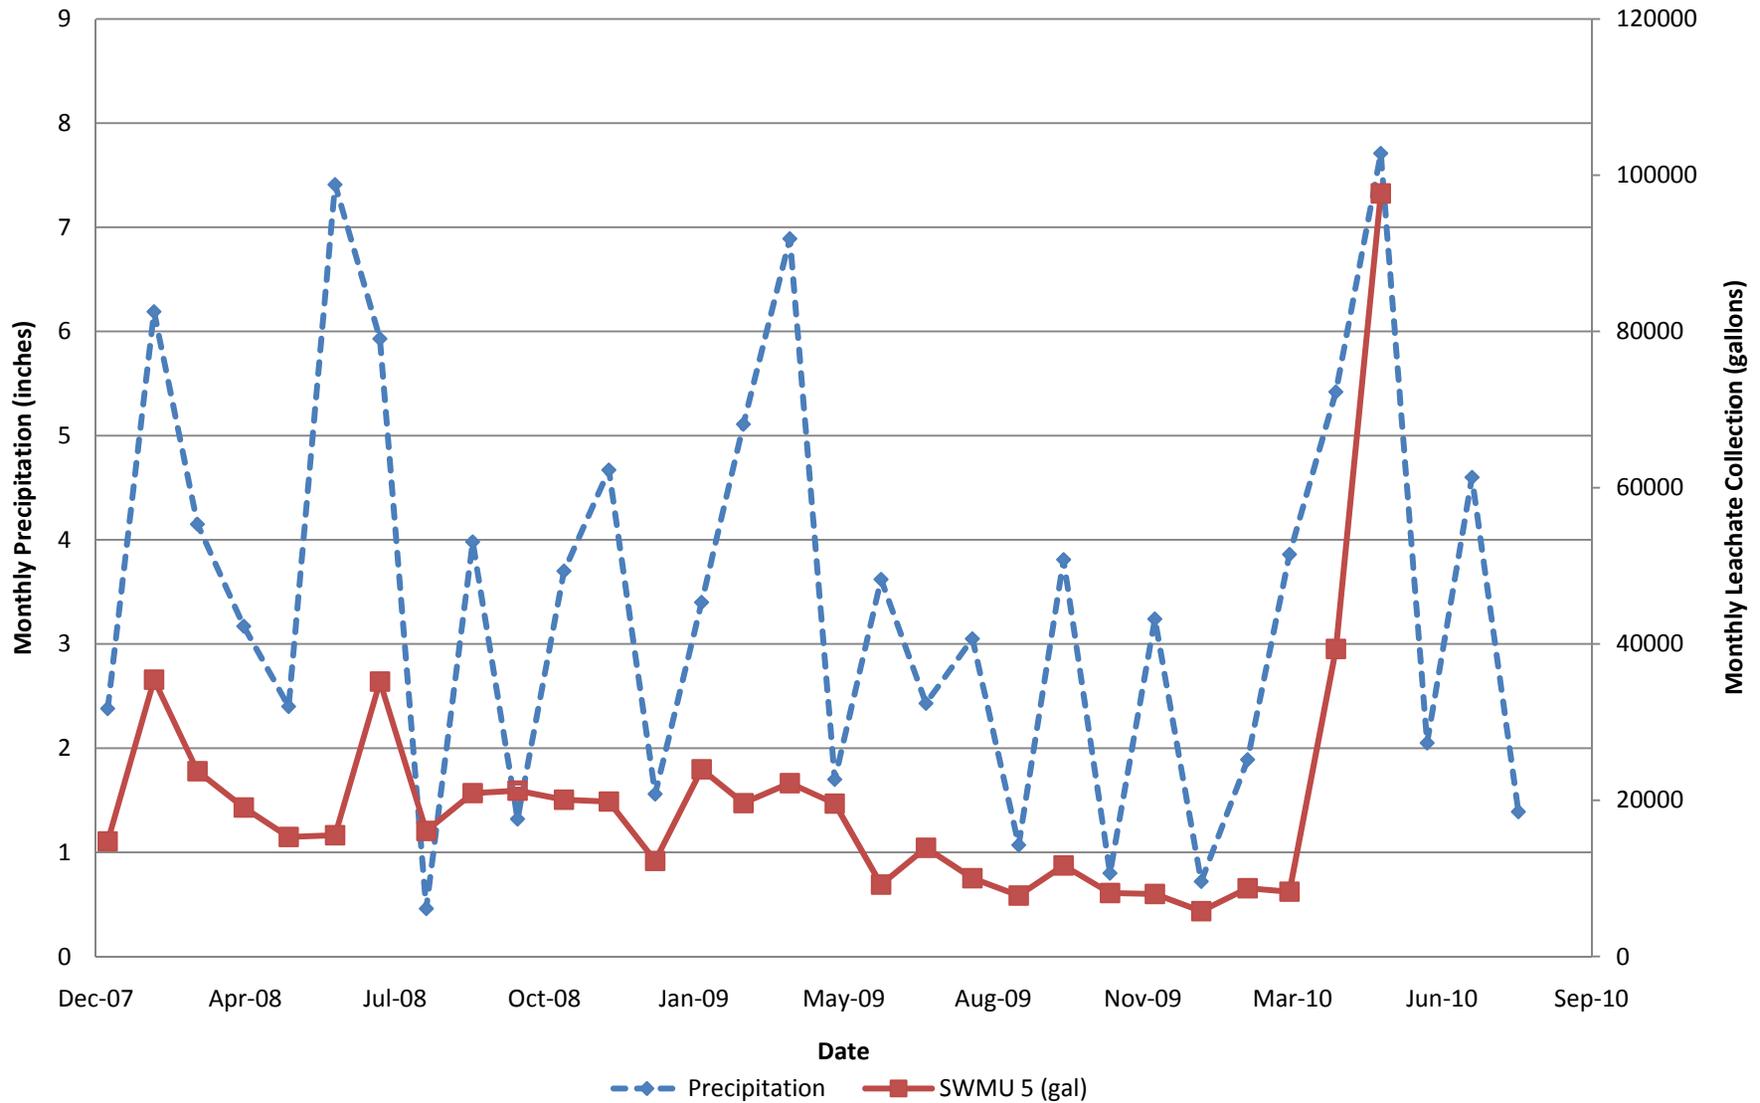
## Precipitation vs. Leachate Recovery at SWMU 5 ESOI Otter Creek Facility, Oregon, Ohio

Note: Between January and April 2010, the maintenance program for the leachate recovery wells was modified to increase leachate recovery.

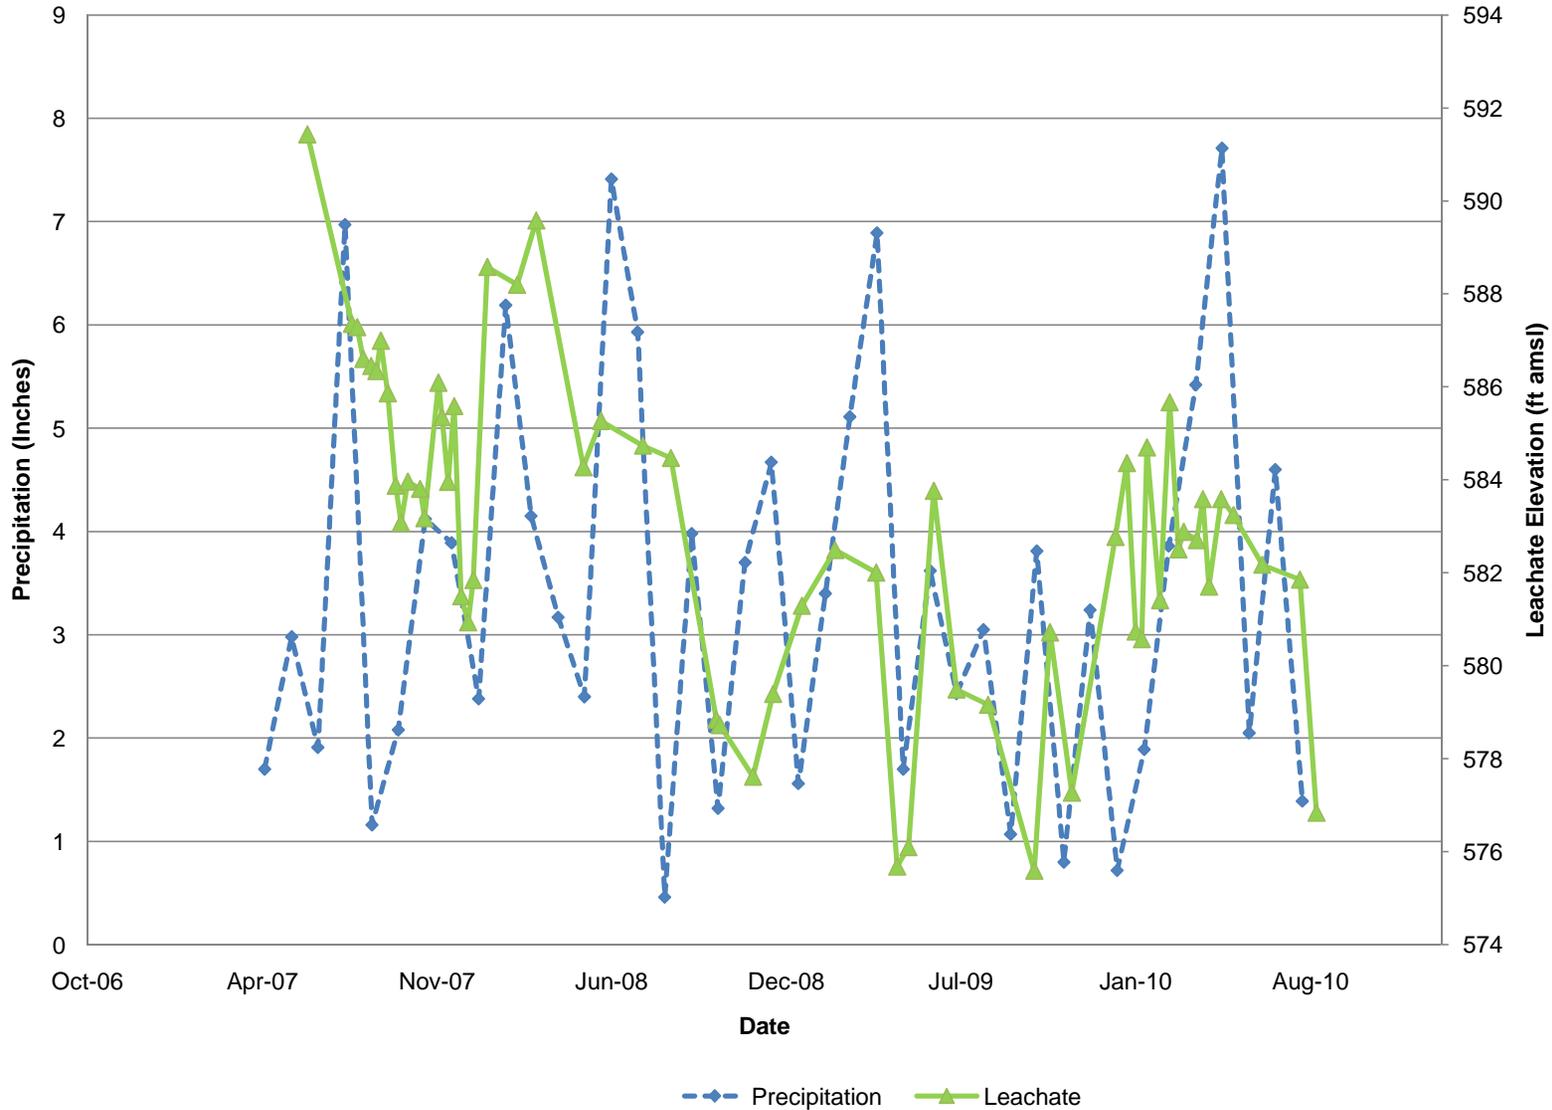
## Precipitation vs. Leachate Level at SWMU 6 ESOI Otter Creek Facility, Oregon, Ohio
