## **APPENDIX A**

### **Supplemental Facility Monitoring Data**

# ENVIROSAFE SERVICES OF OHIO, INC.

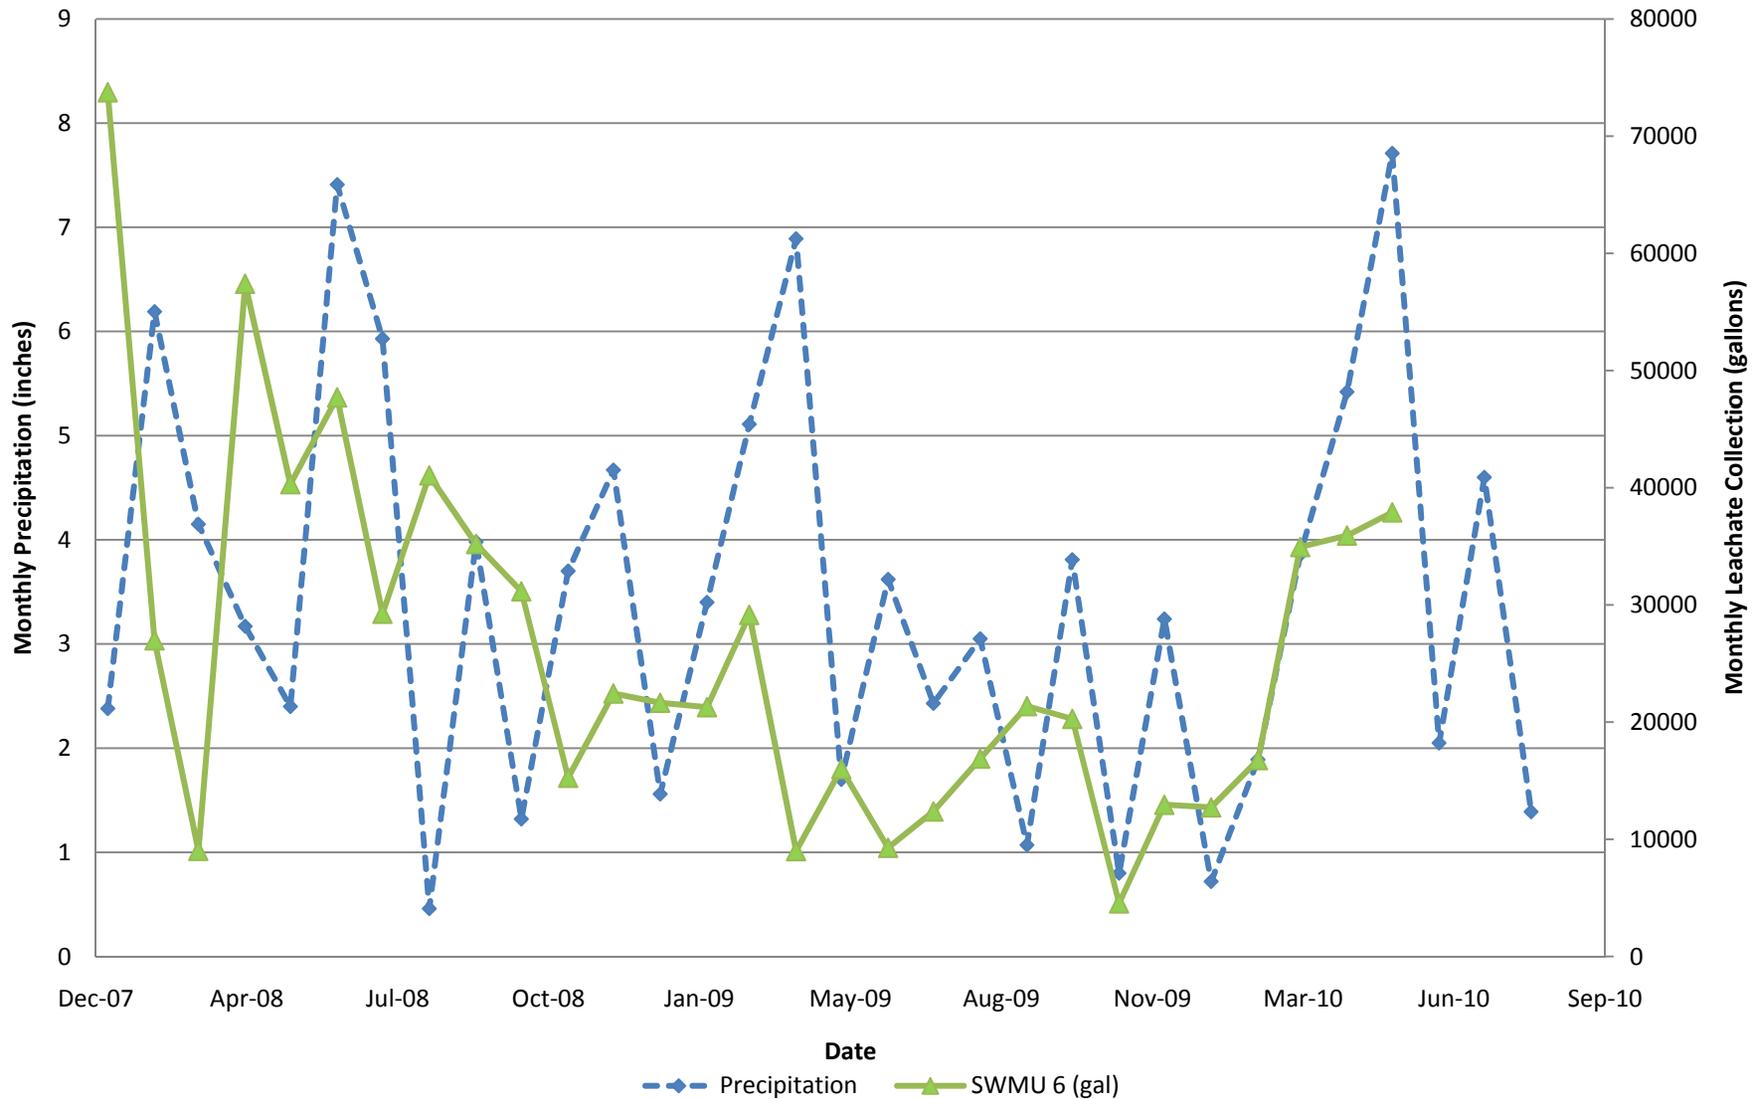
## Precipitation vs. Leachate Recovery at SWMU 6 ESOI Otter Creek Facility, Oregon, Ohio

Note: Between January and April 2010, the maintenance program for the leachate recovery wells was modified to increase leachate recovery.

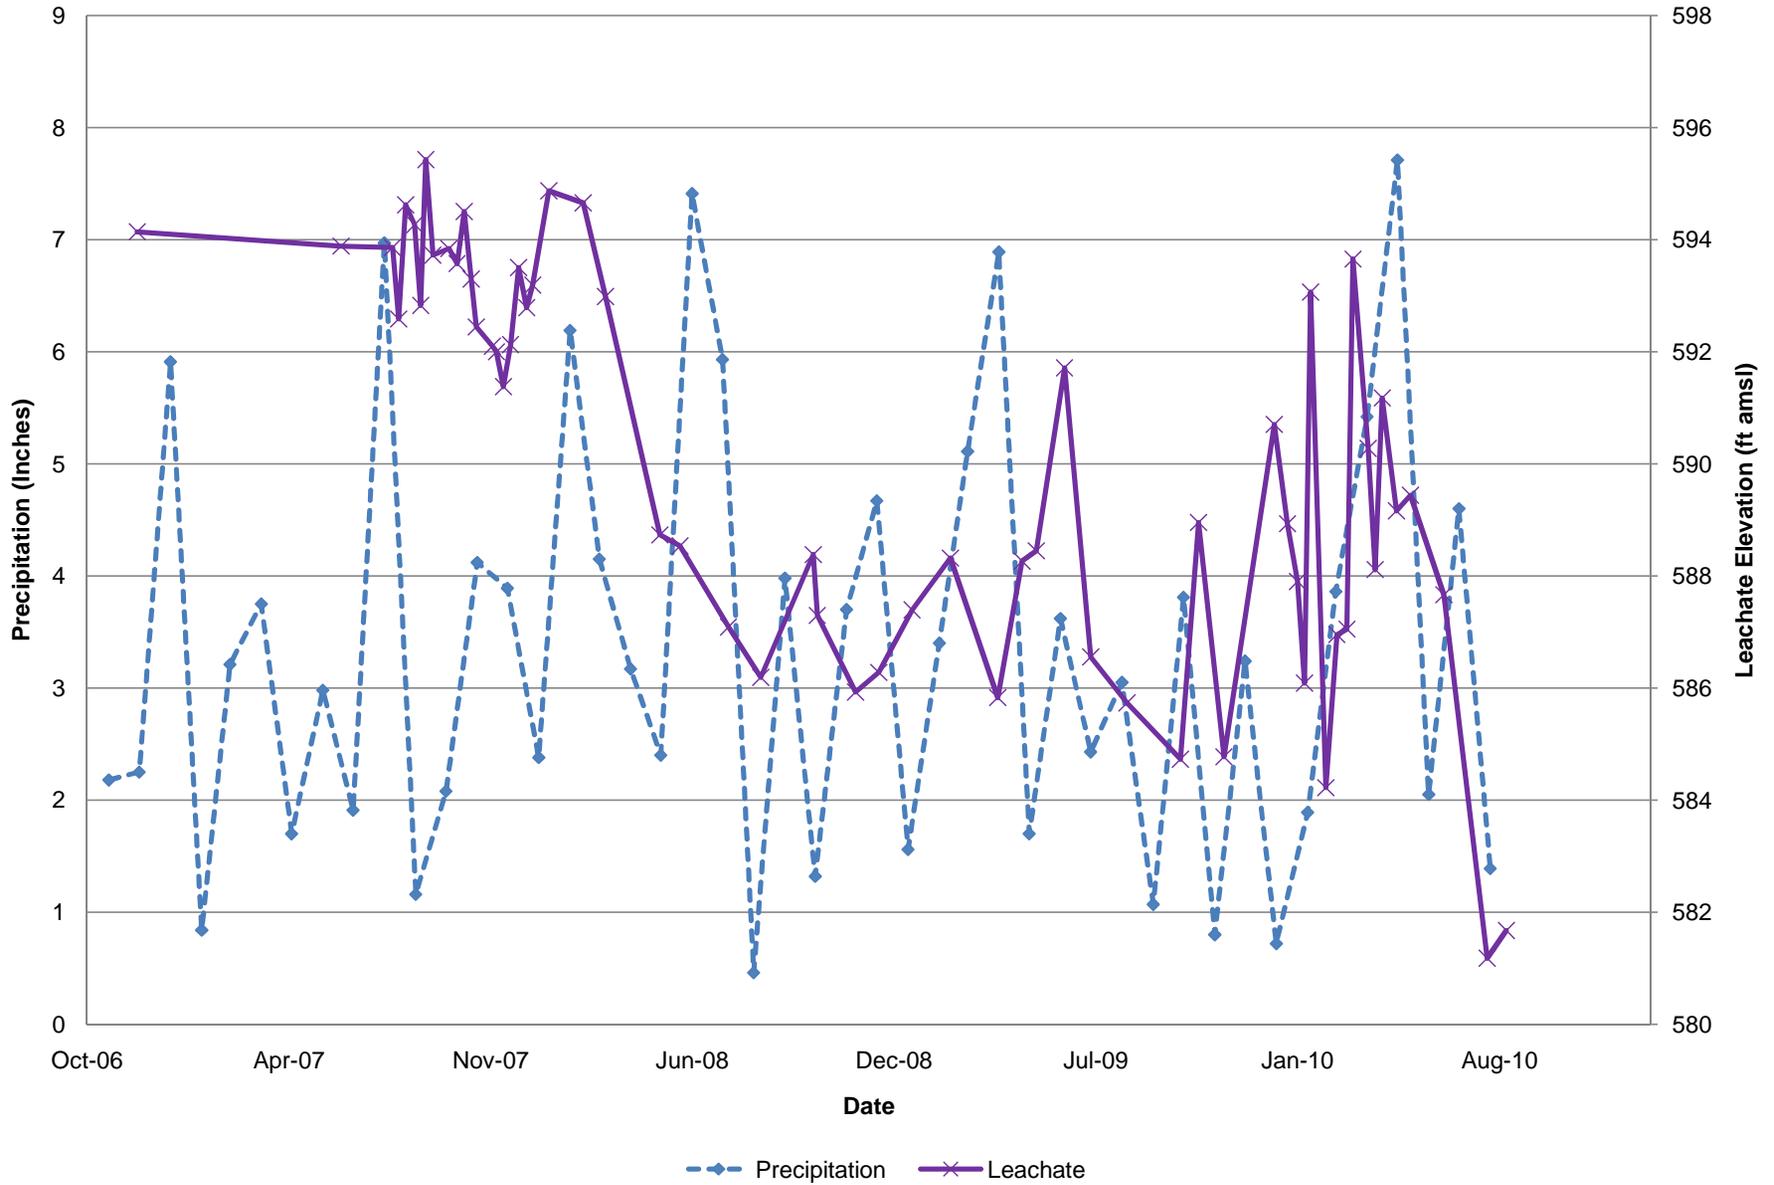
## Precipitation vs. Leachate Level at SWMU 7 ESOI Otter Creek Facility, Oregon, Ohio

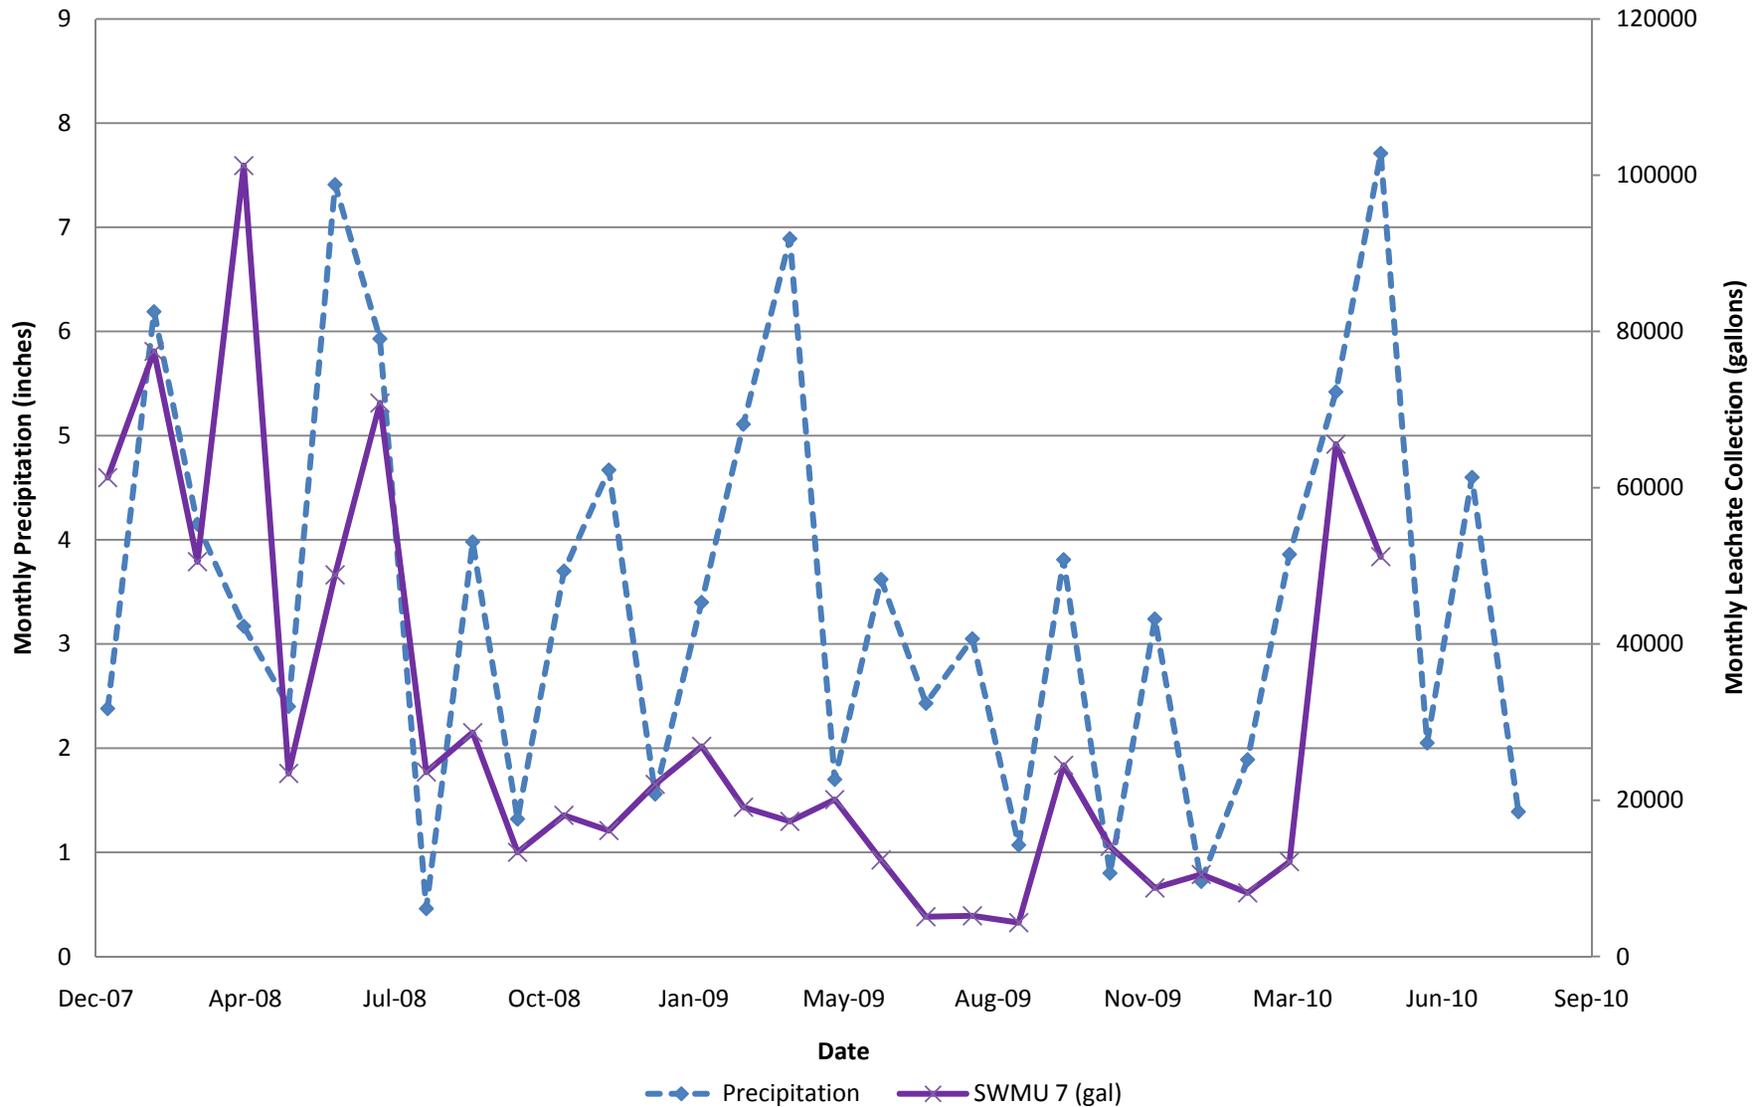
## Precipitation vs. Leachate Recovery at SWMU 7 ESOI Otter Creek Facility, Oregon, Ohio

Note: Between January and April 2010, the maintenance program for the leachate recovery wells was modified to increase leachate recovery.

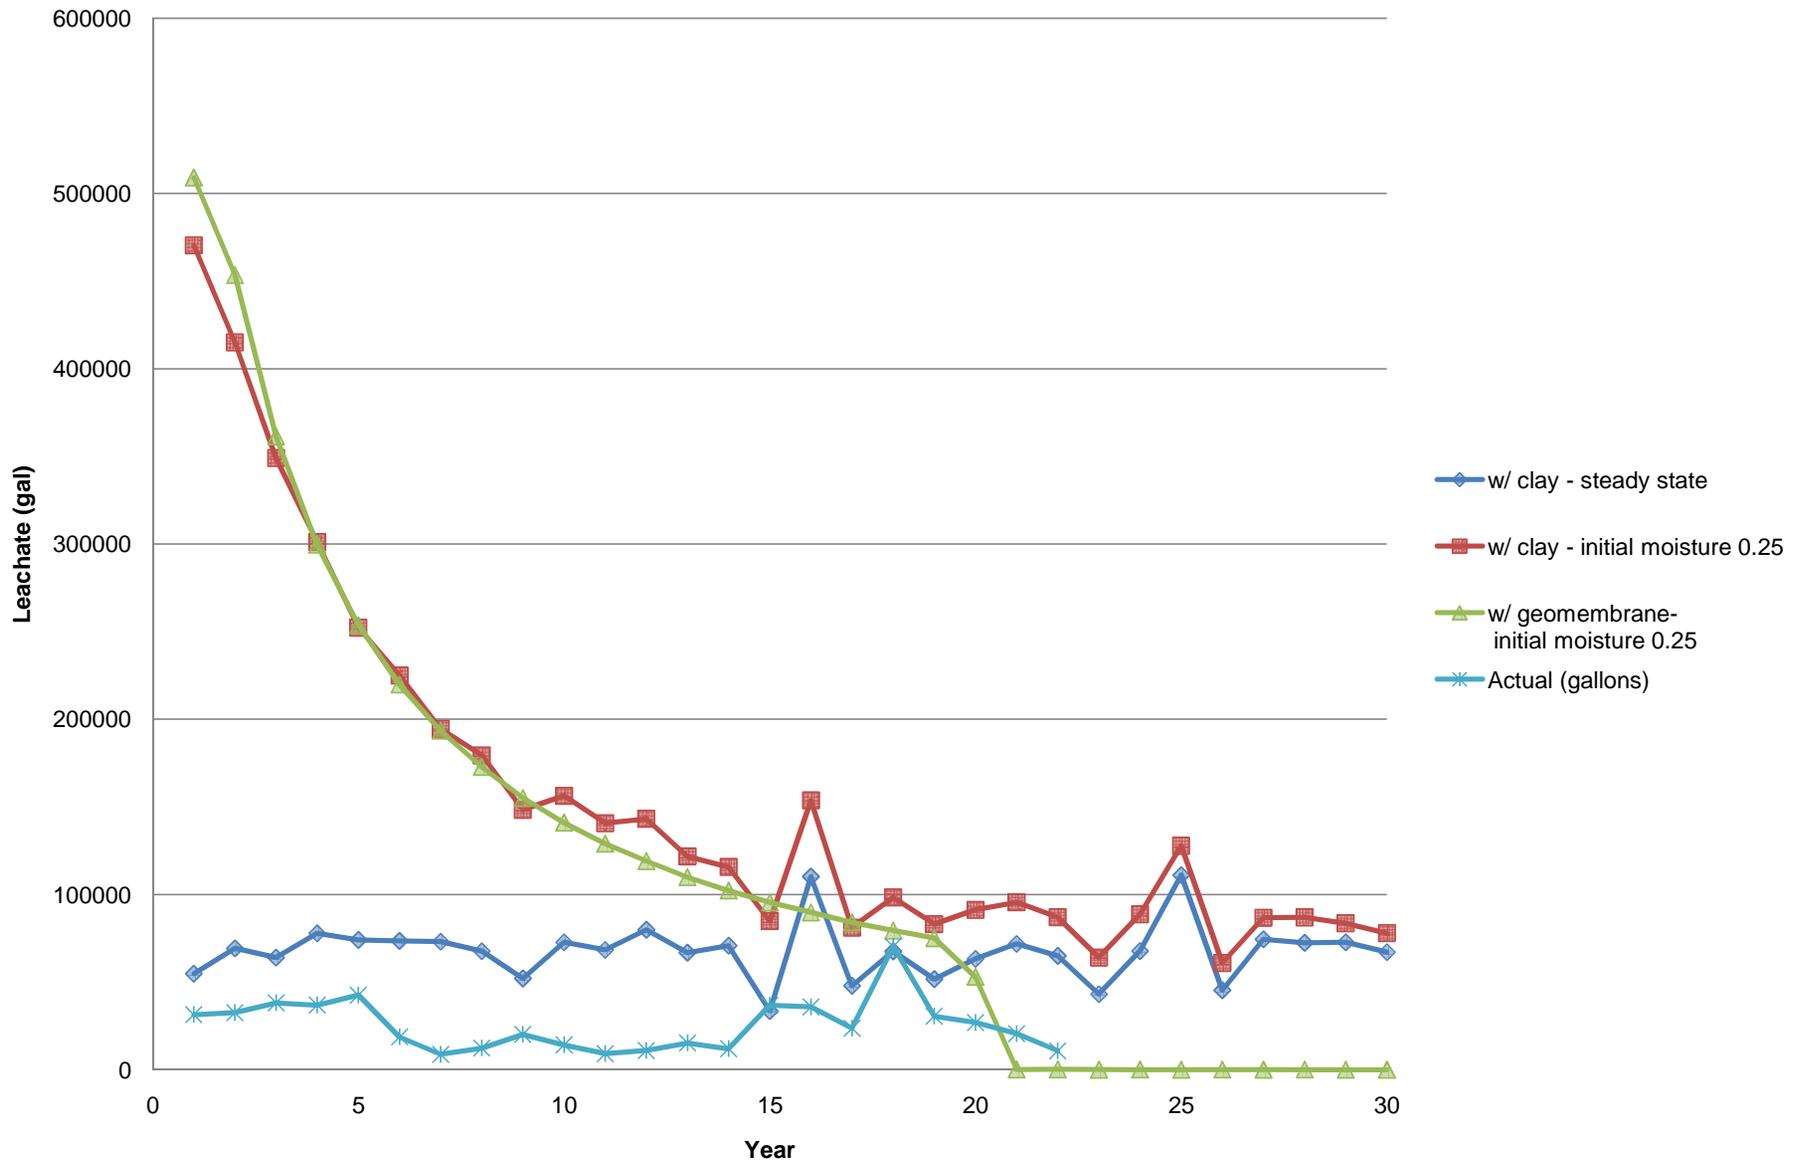
## Modeled Leachate Generation - SWMU 1 ESOI Otter Creek Facility, Oregon, Ohio

The actual leachate collection data from SWMU 1 was compared to the estimated leachate generation rates from the HELP model, and the model was found to over-predict the annual leachate volume by an average factor of 3.7. Therefore, a conservative site-specific adjustment factor of 2.5 was applied to the modeled leachate volumes for SWMU 1 to estimate the cost of leachate treatment and disposal for this unit.

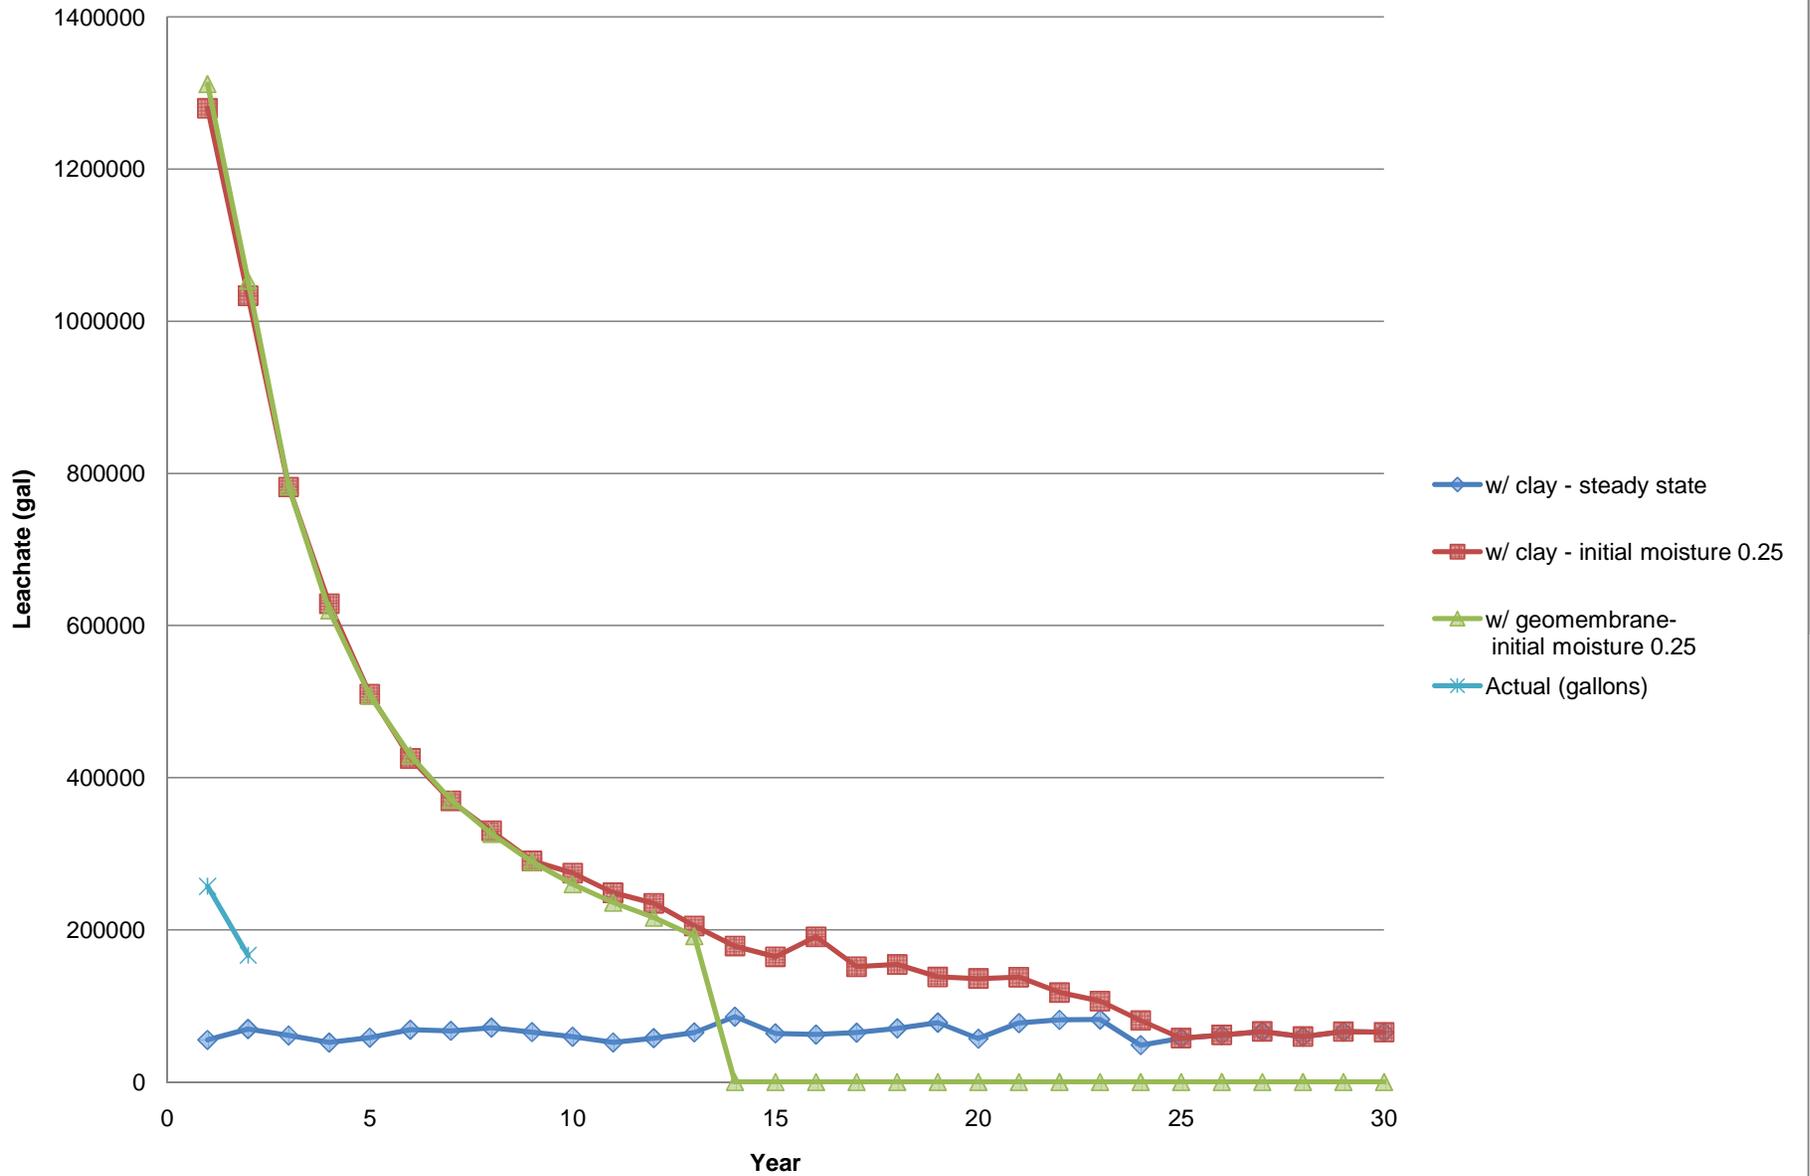
## Modeled Leachate Generation - SWMU 5 ESOI Otter Creek Facility, Oregon, Ohio

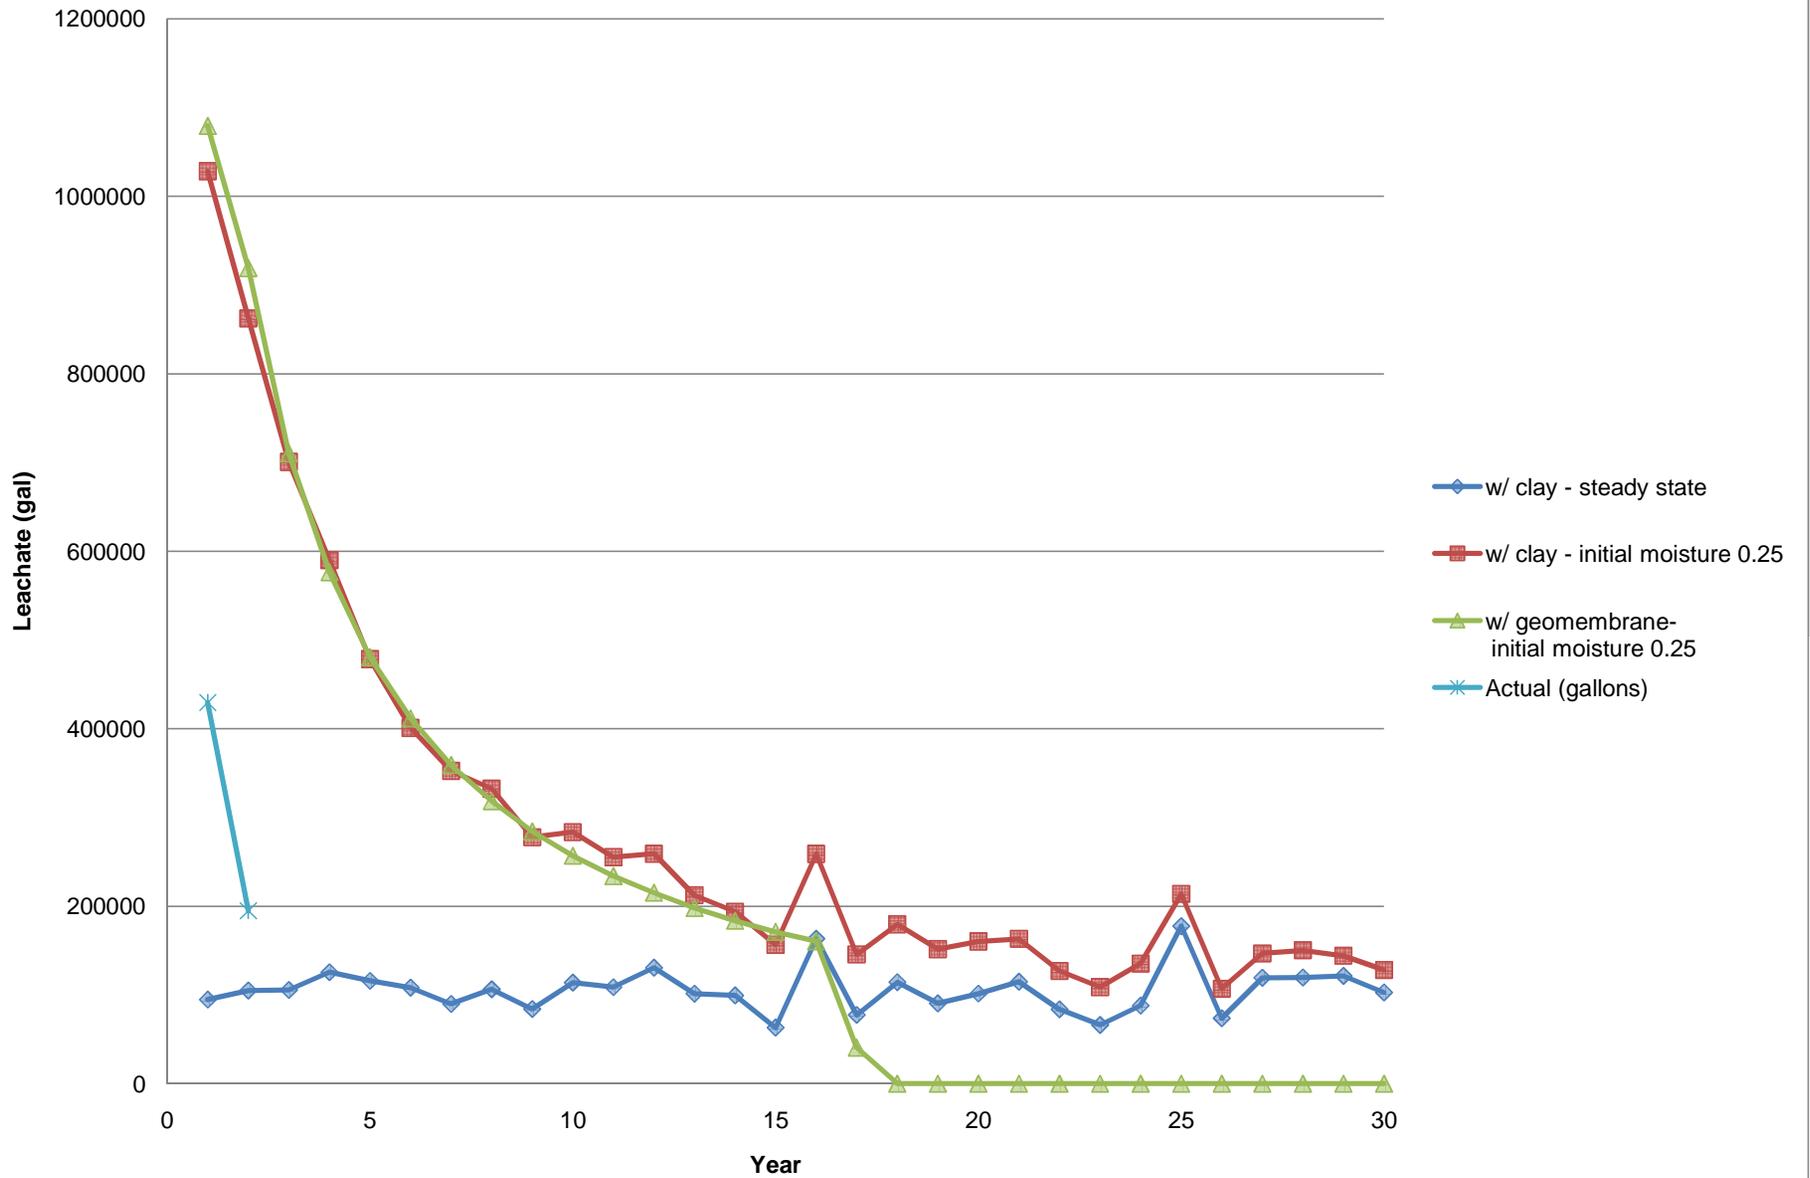
## Modeled Leachate Generation - SWMU 6 ESOI Otter Creek Facility, Oregon, Ohio

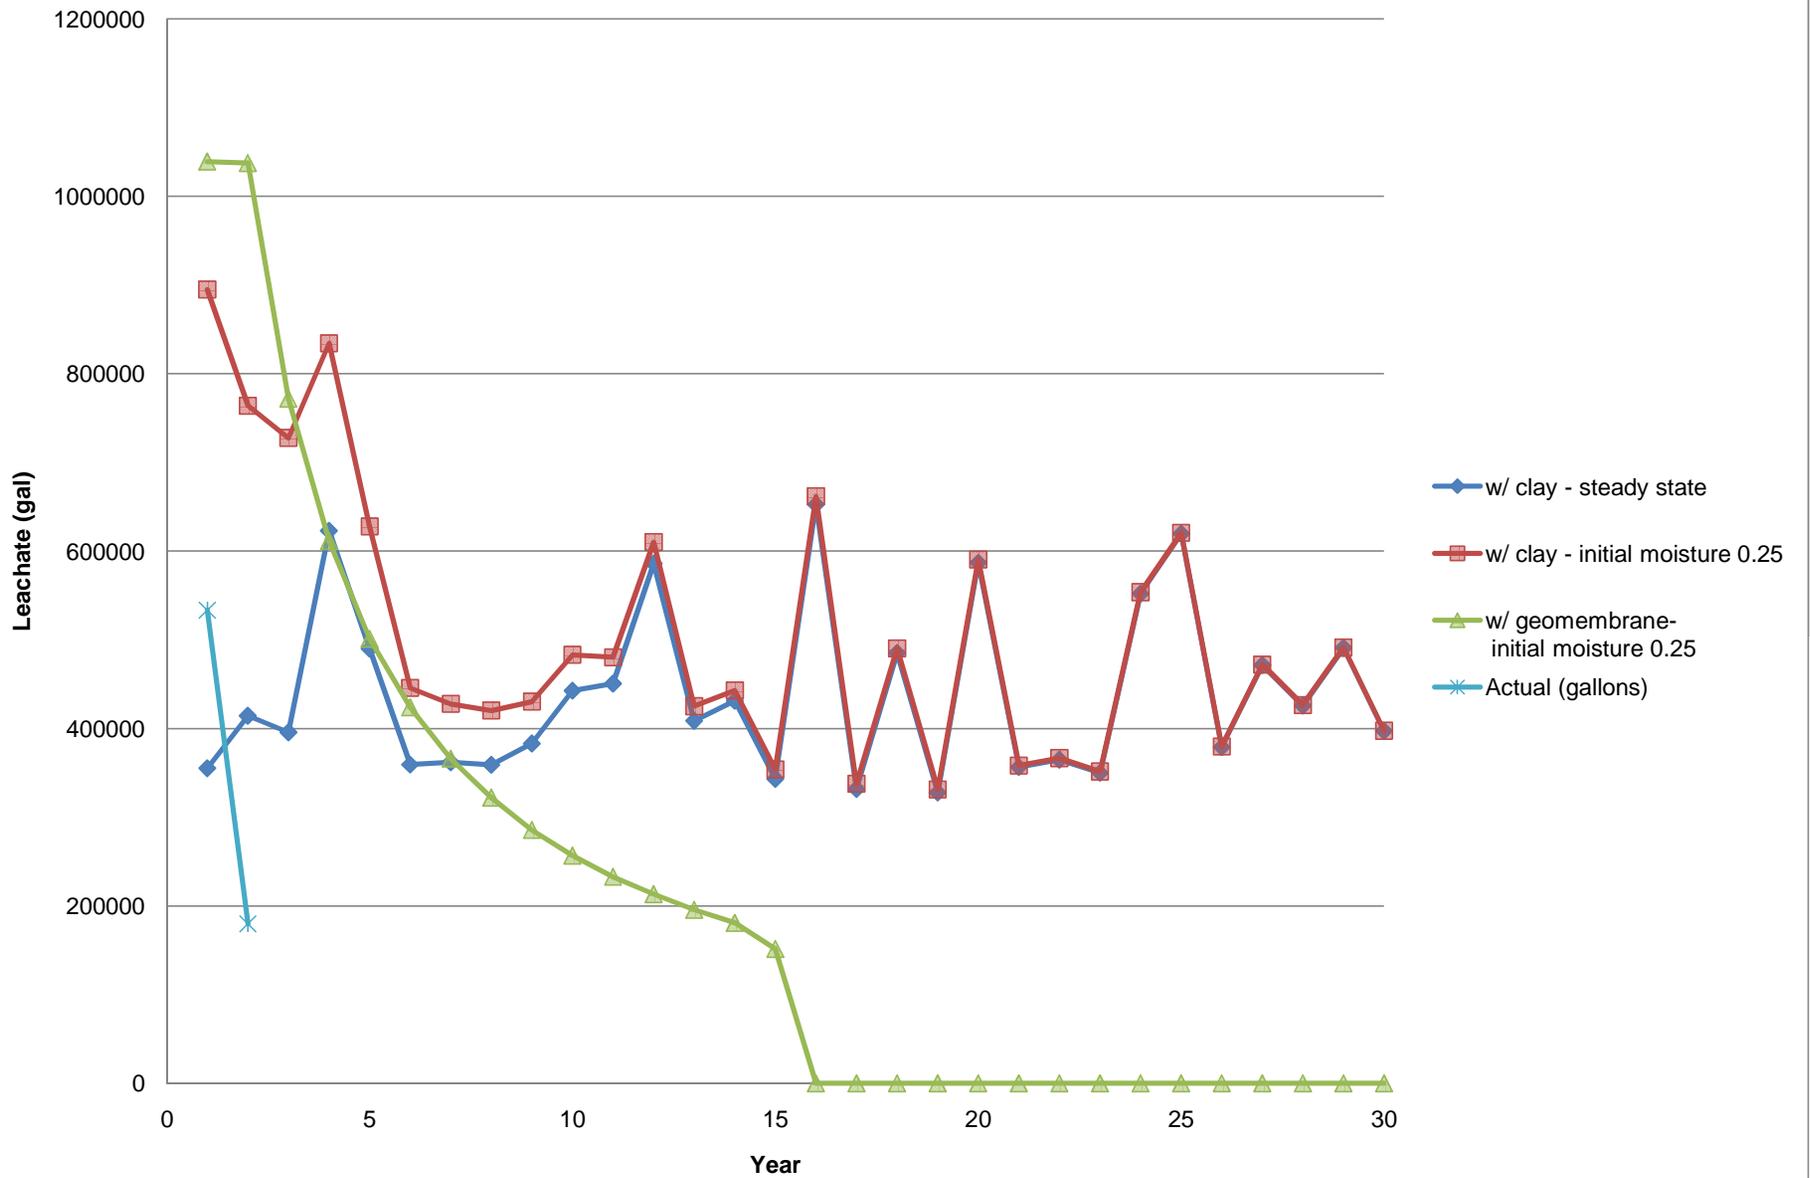
## Modeled Leachate Generation - SWMU 7 ESOI Otter Creek Facility, Oregon, Ohio

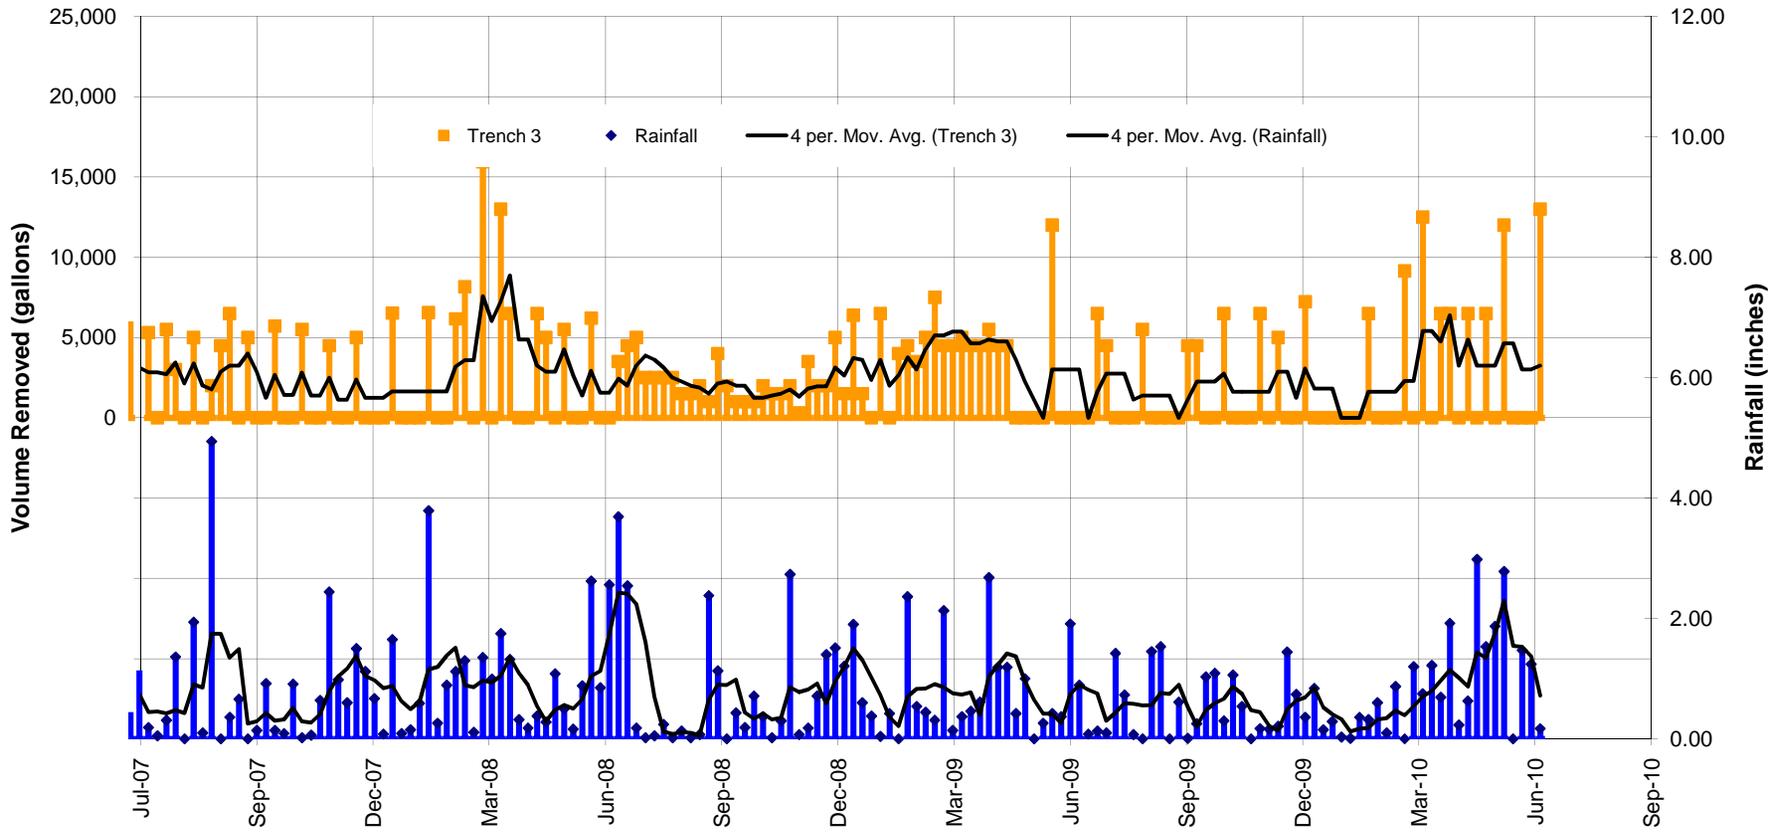
### Summary of Water Removed from Dewatering Trench 3 and Rainfall

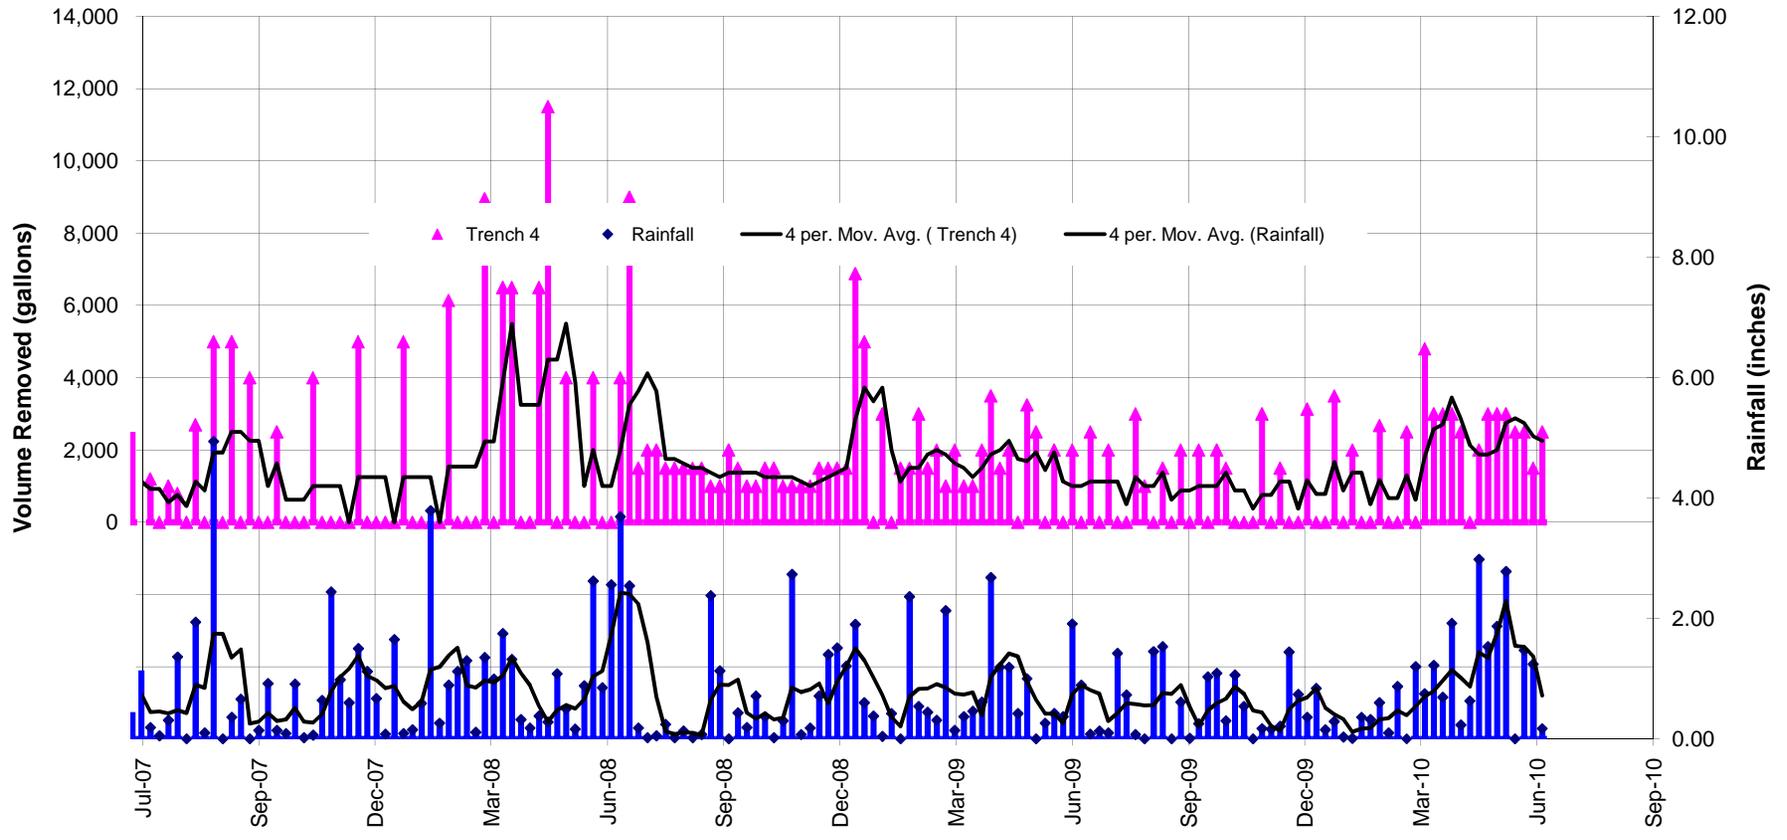
### Summary of Water Removed from Dewatering Trench 4 and Rainfall

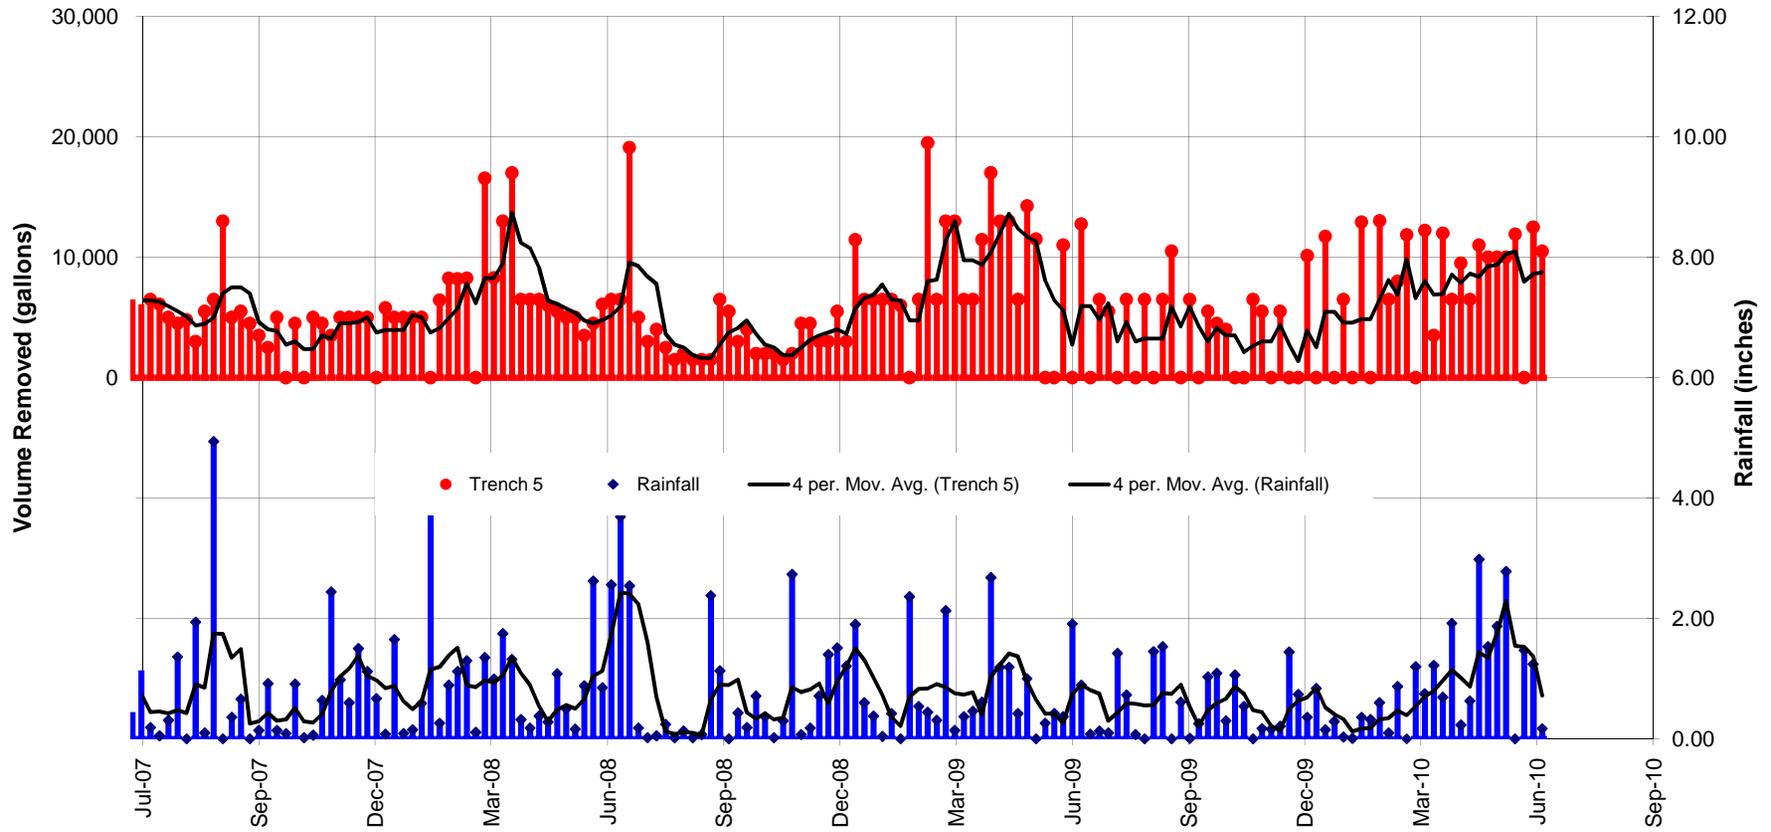
### Summary of Water Removed from Dewatering Trench 5 and Rainfall

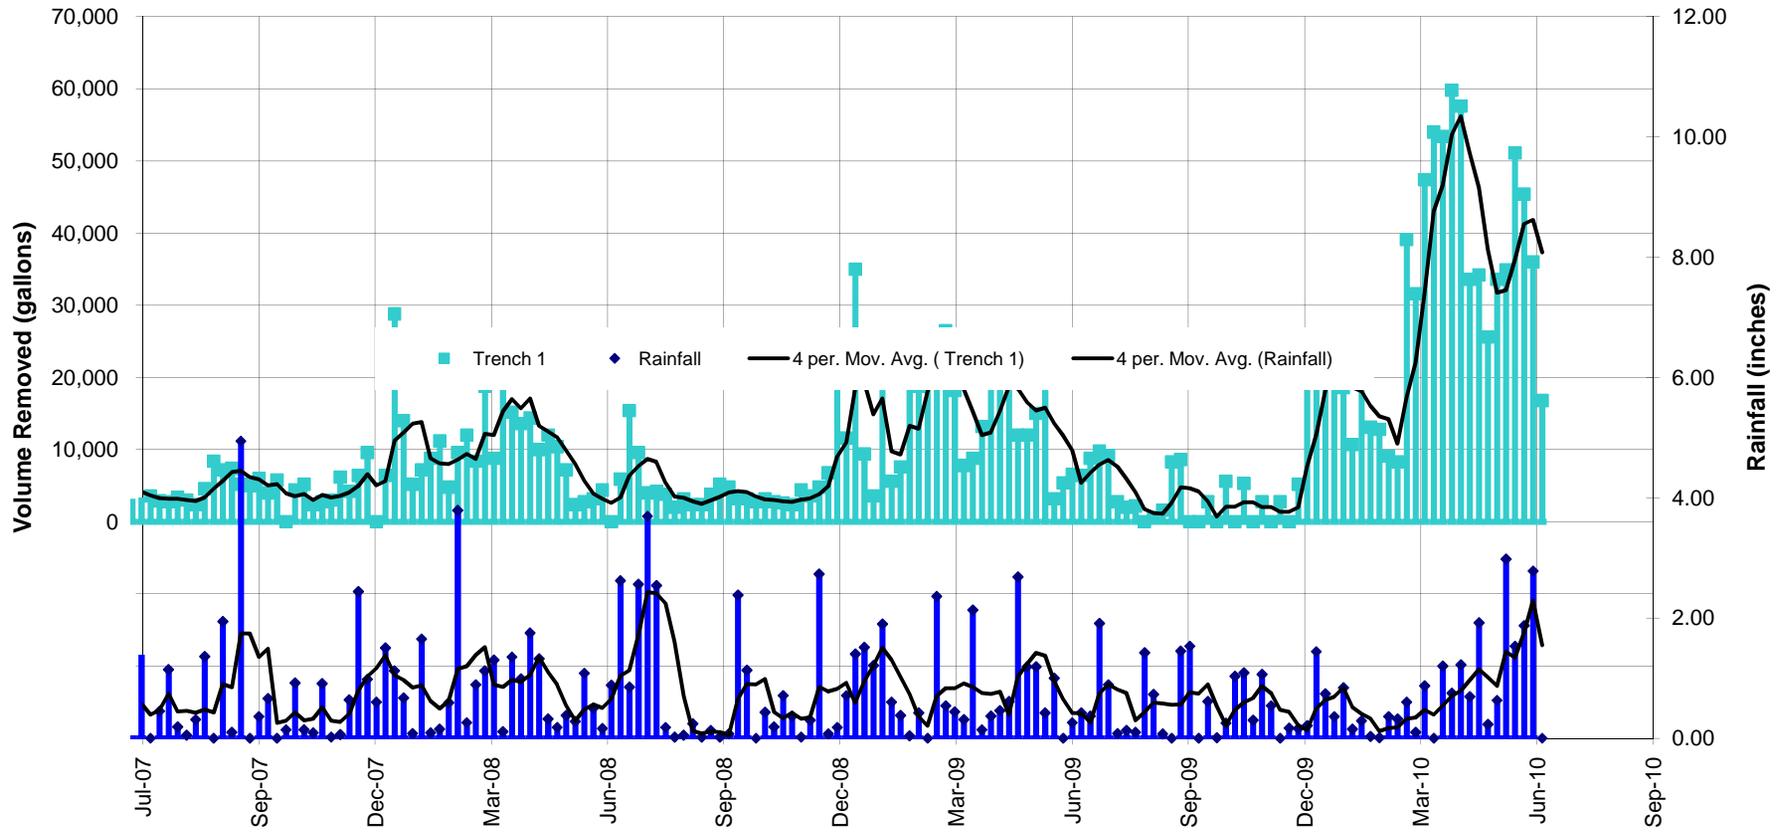
### Summary of Water Removed from Monitoring Trench 1 and Rainfall

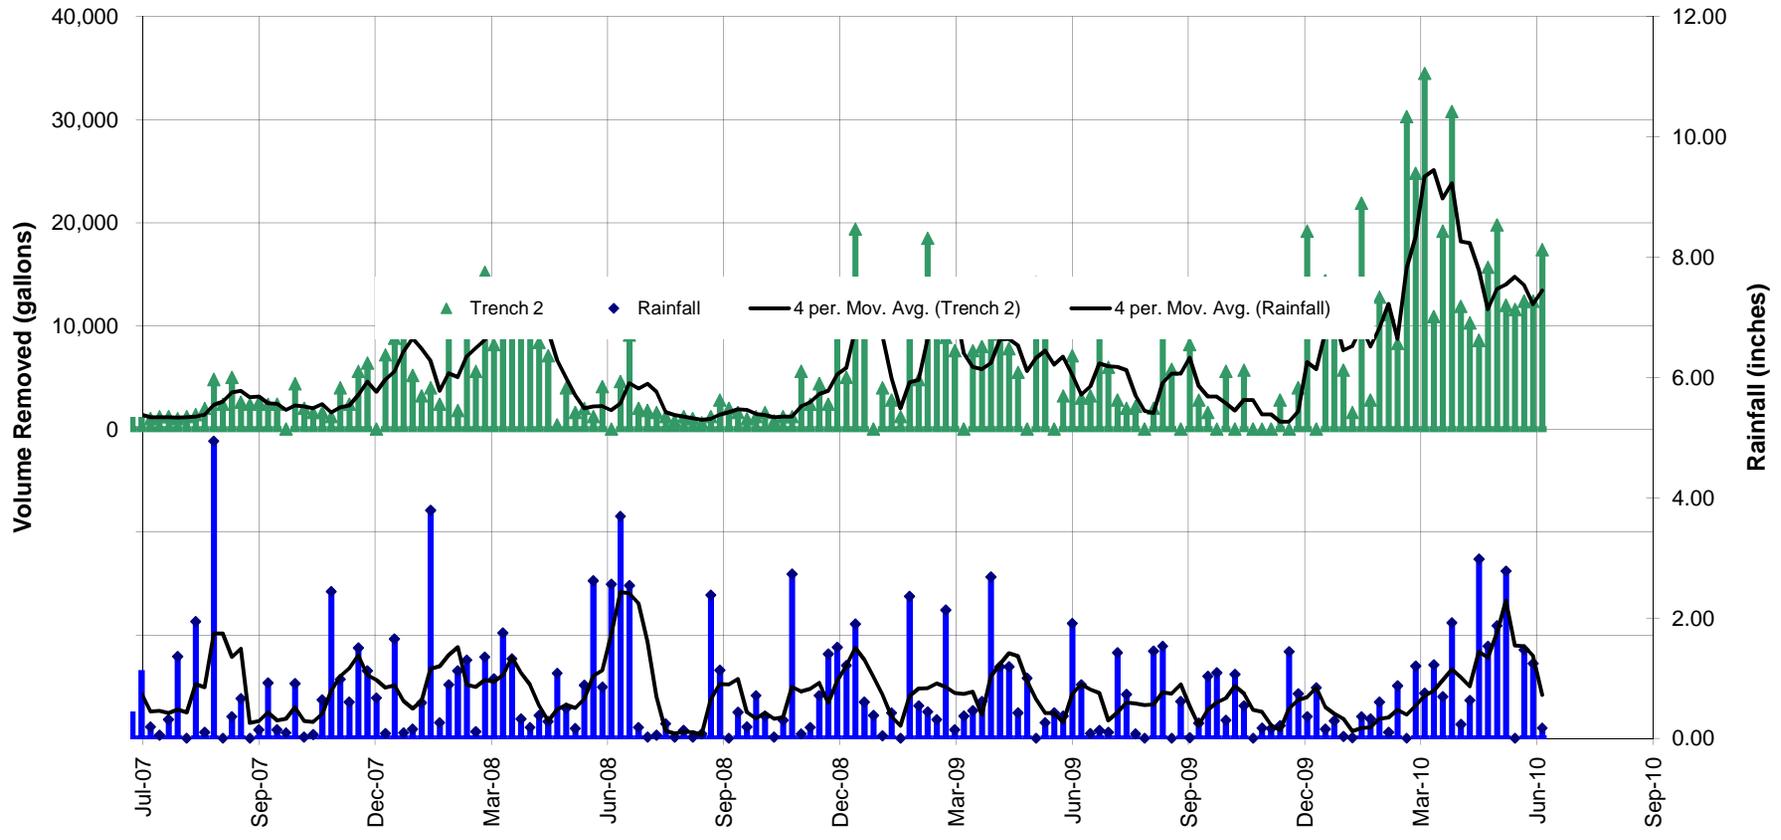
### Summary of Water Removed from Monitoring Trench 2 and Rainfall
