## **APPENDIX A**

### **Supplemental Facility Monitoring Data**

# ENVIROSAFE SERVICES OF OHIO, INC.

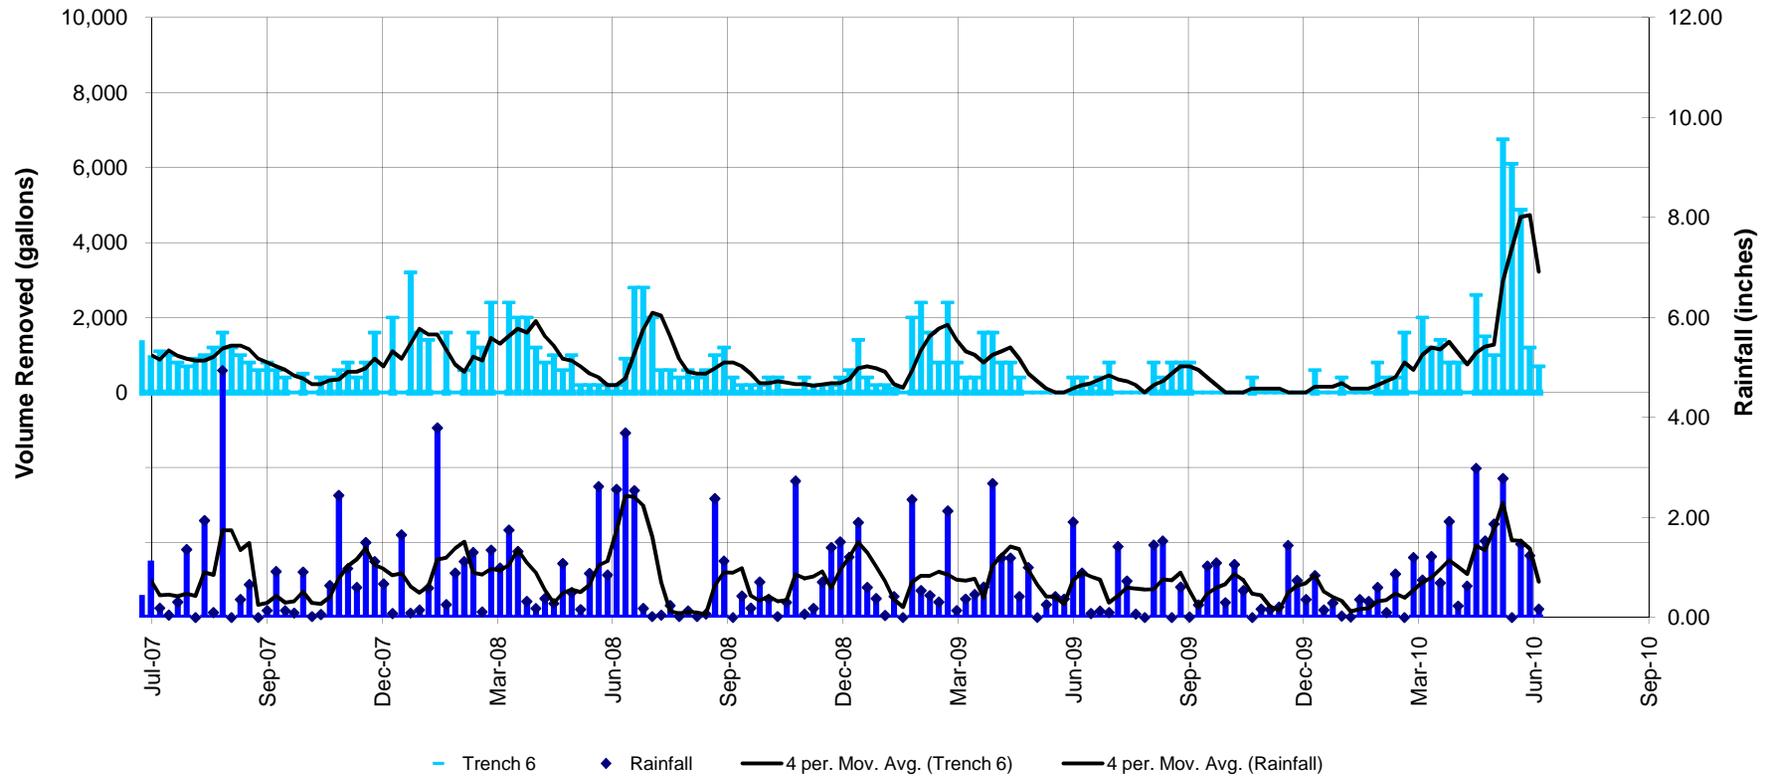
### Summary of Water Removed from Monitoring Trench 6 and Rainfall

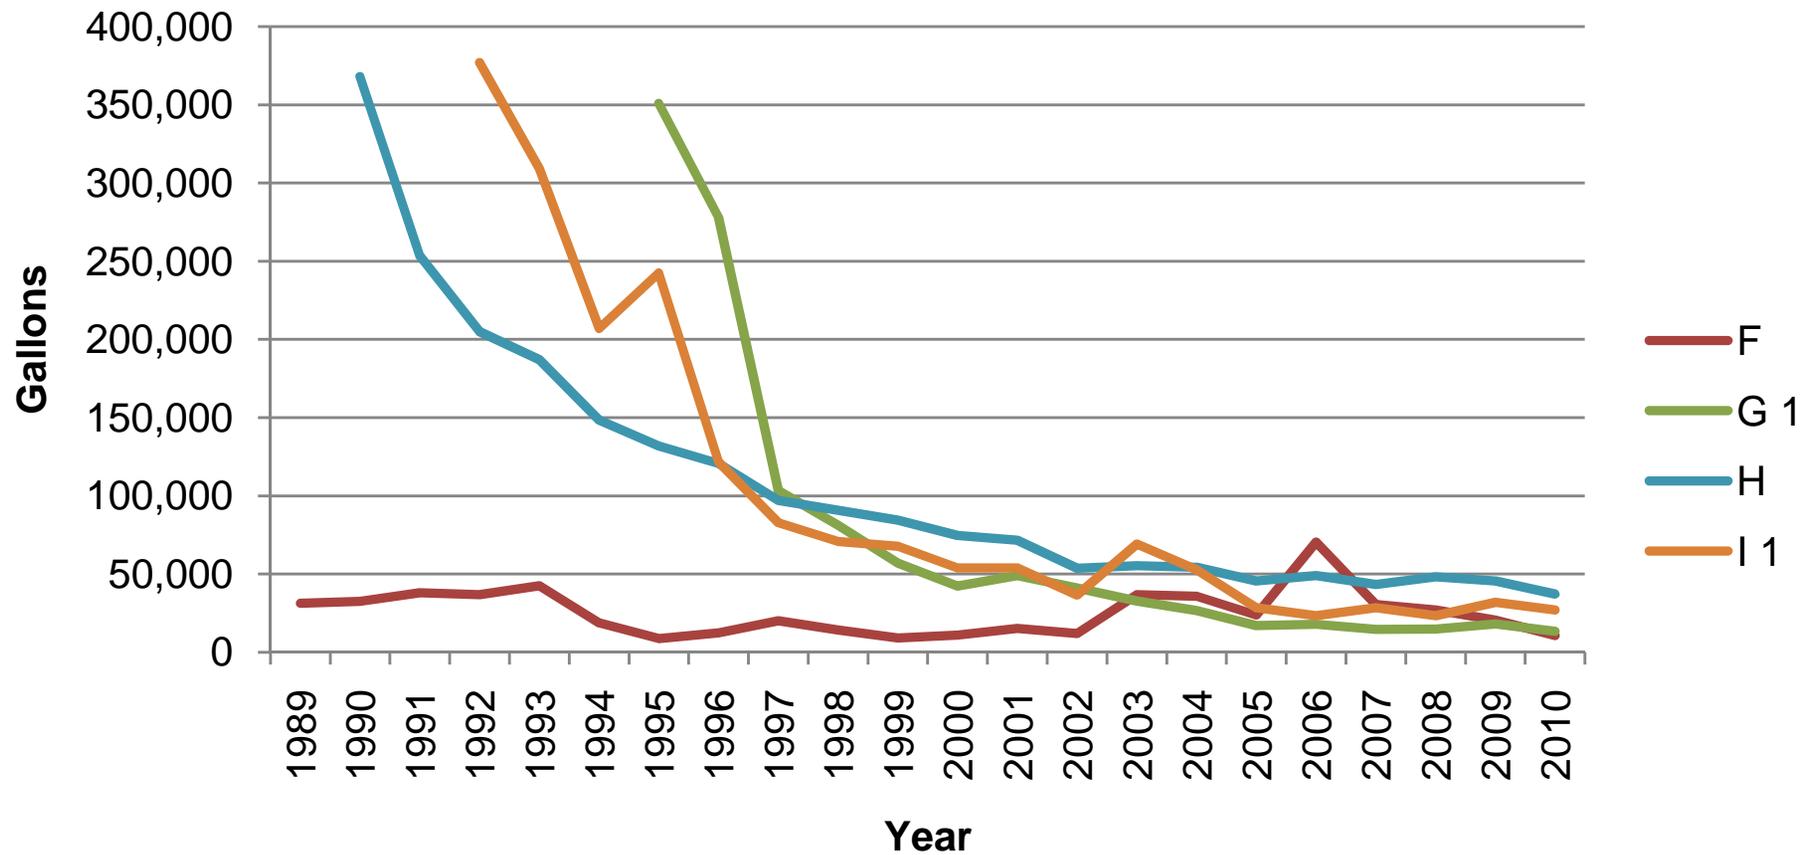
# Leachate Recovery at Cell F, G, H, and I ESOI Otter Creek Facility, Oregon, Ohio

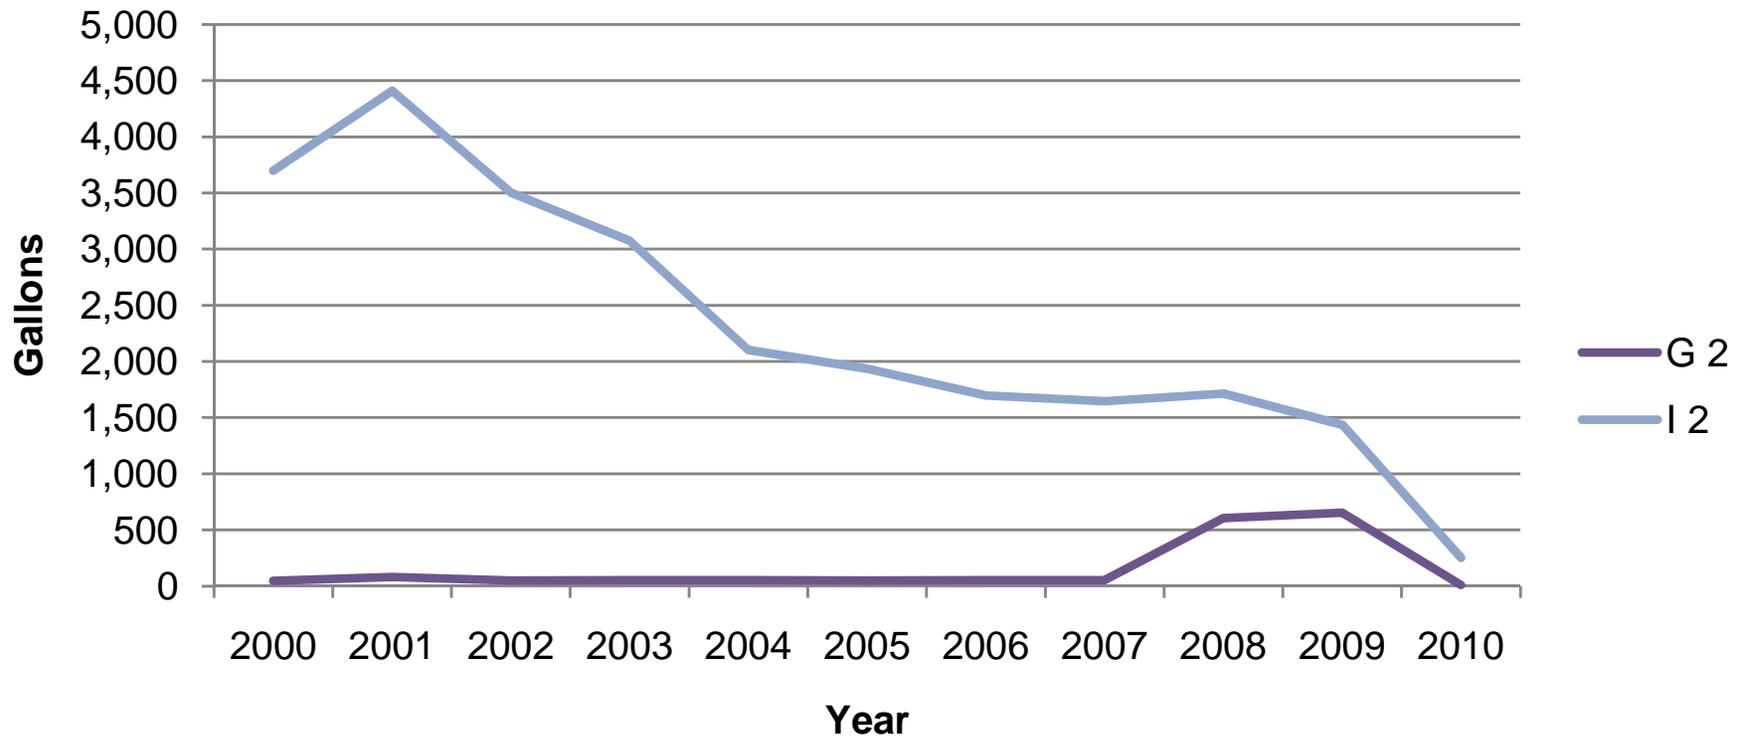
# Leachate Recovery from Secondary Liner at Cell G and I ESOI Otter Creek Facility, Oregon, Ohio

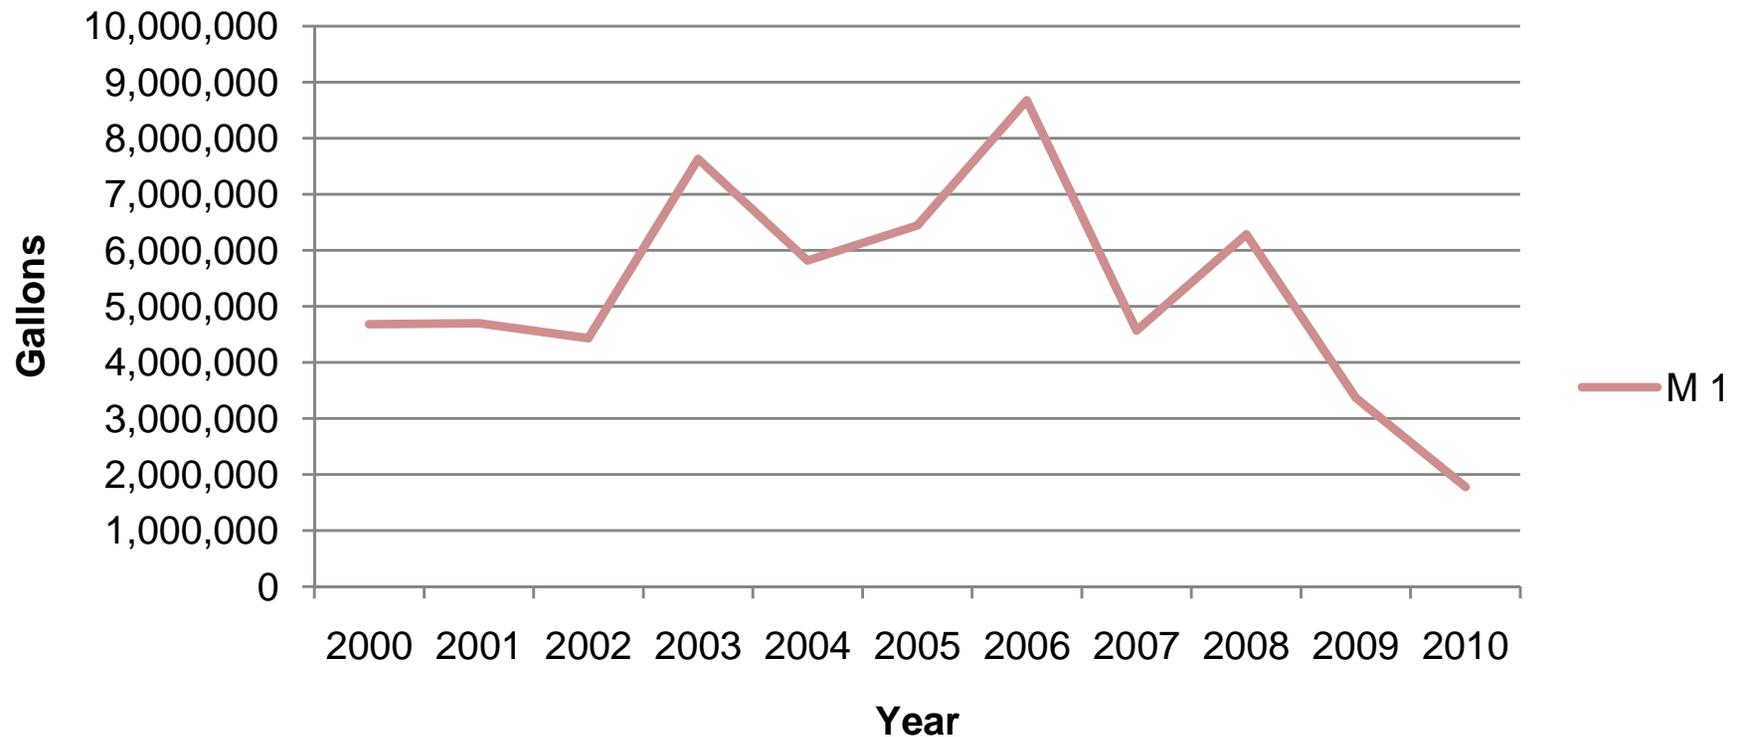
# Leachate Recovery from Primary Liner at Cell M

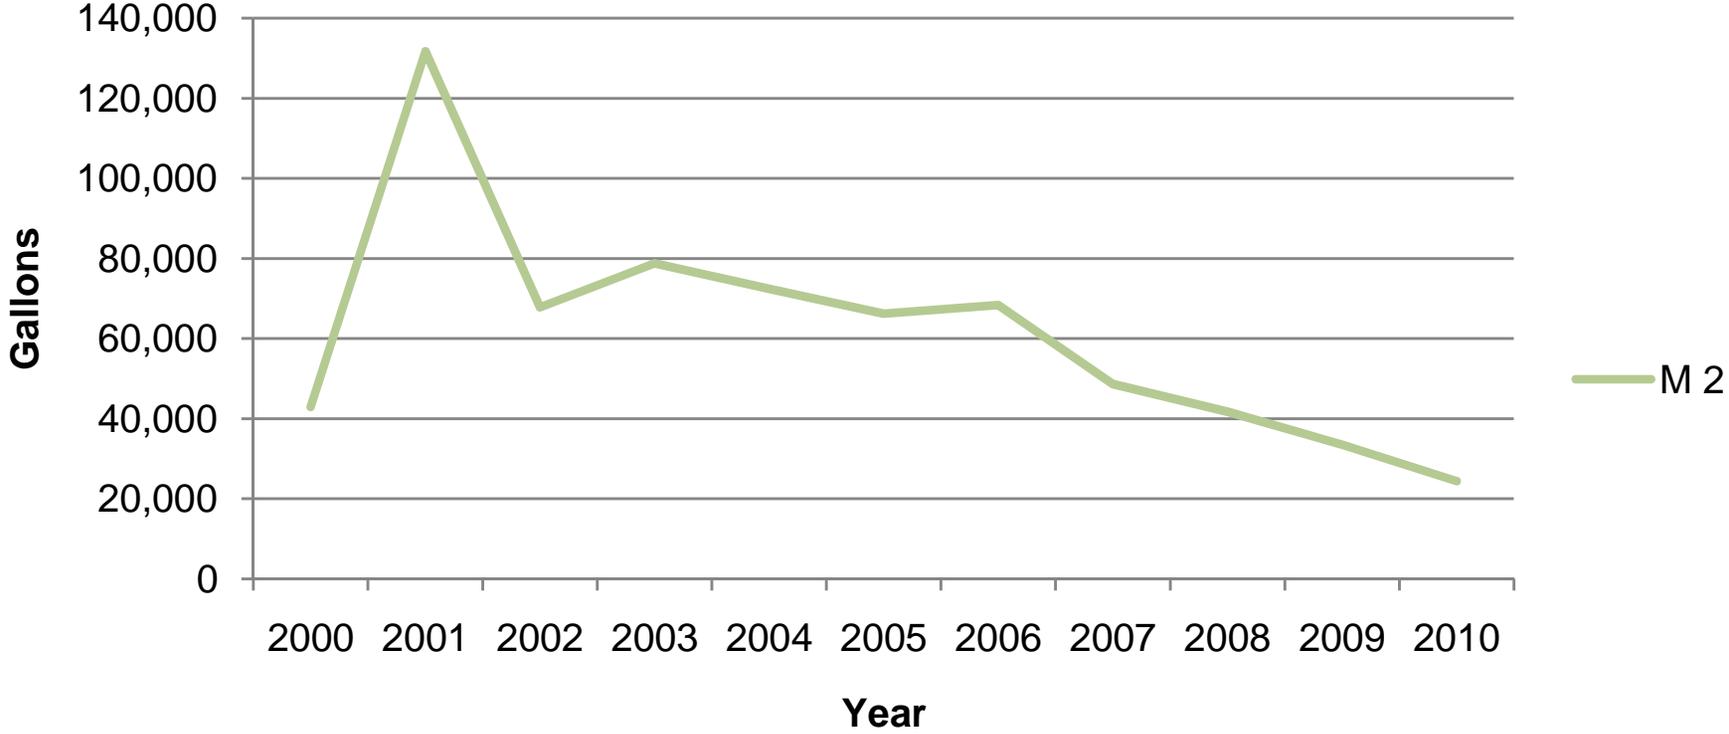
# Leachate Recovery from Secondary Liner at Cell M ESOI Otter Creek Facility, Oregon, Ohio
