APPENDIX A

Supplemental Facility Monitoring Data

Bedrock Groundwater Mapping
Surface Drainage Inspection
ENVIRON Inspection Report
RFI Soil Screening Criteria
Post Excavation Sample Data for AOC 6

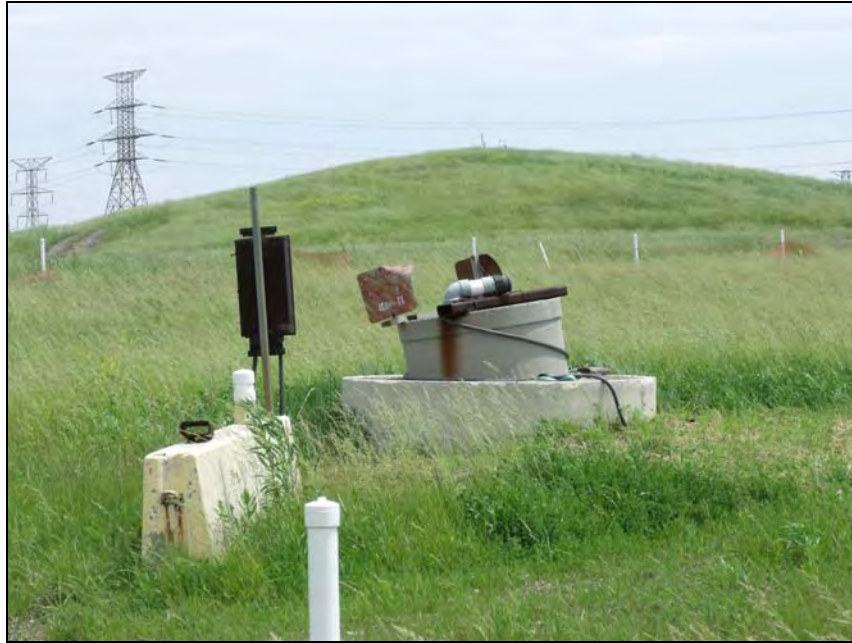
Photo 13: SWMU 1 – Leachate collection sump

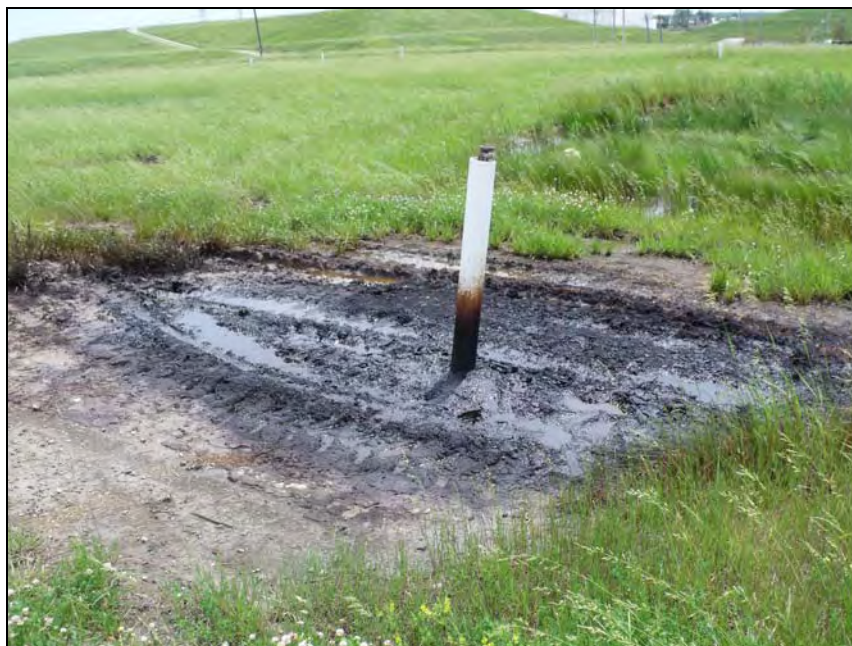
Photo 22: SWMU 9 – stained vent pipe.

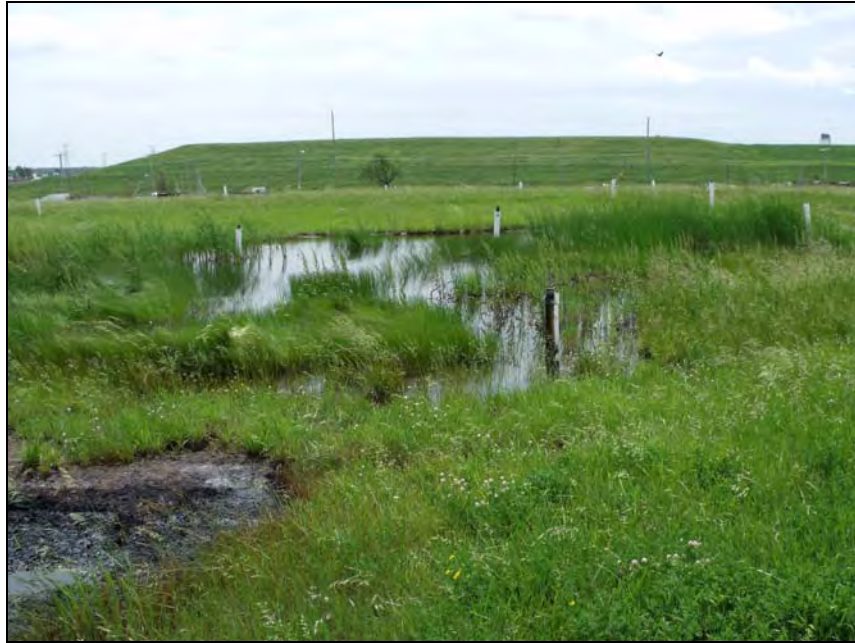
Photo 23: SWMU 9 – stained area and ponding.

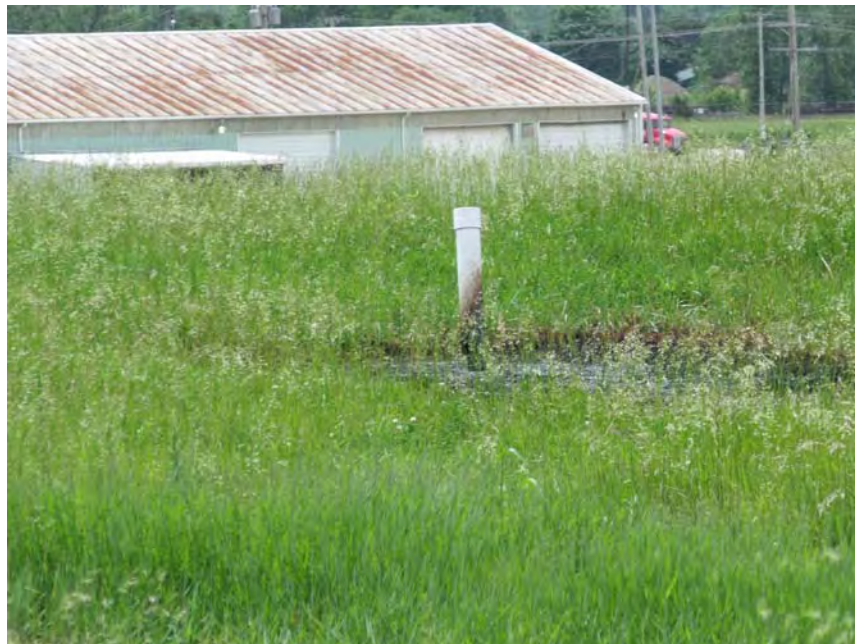
Photo 24: SWMU 9 – stained vent pipe.

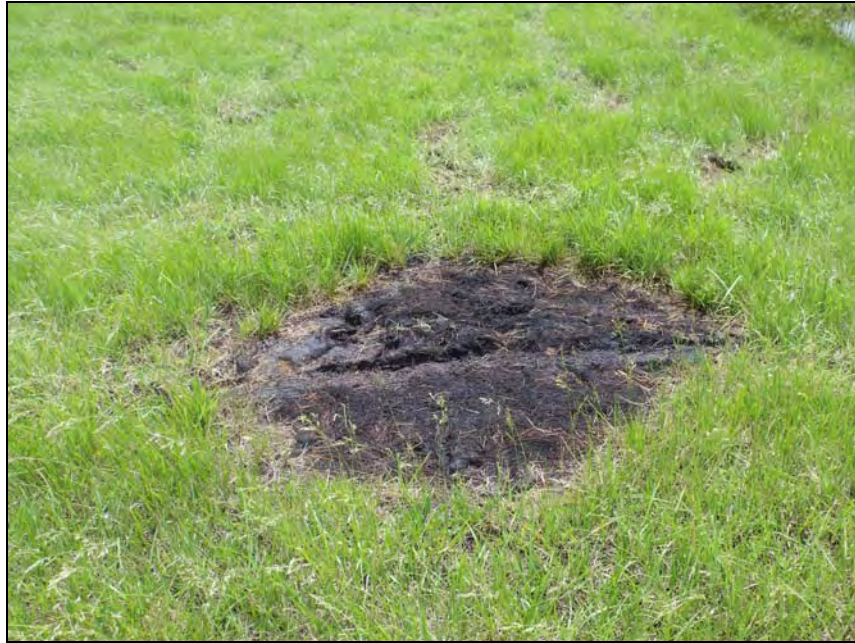
Photo 25: SWMU 9 – stained area.

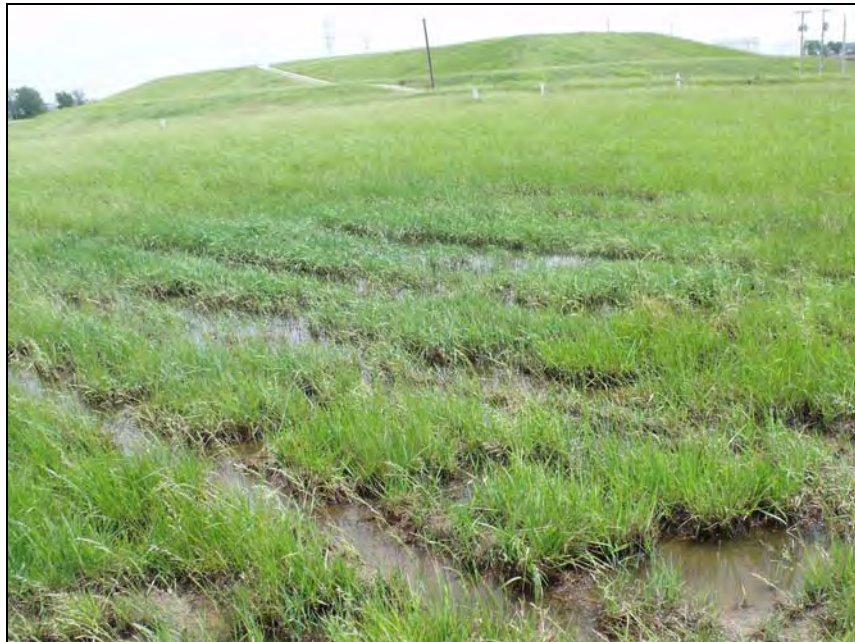
Photo 26: SWMU 9 – standing water

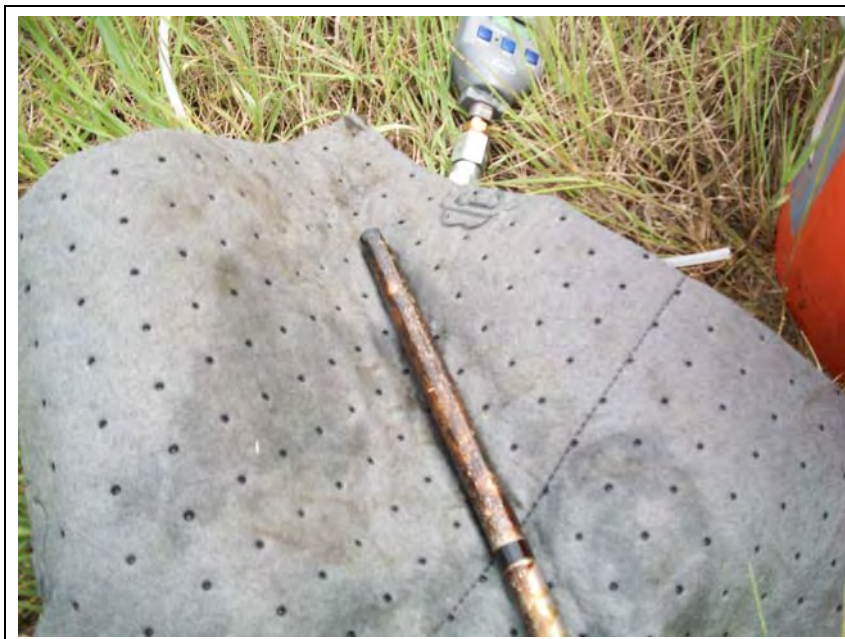
Photo 30: SWMU 8 – O/I probe tip after measurement at TLW-205.

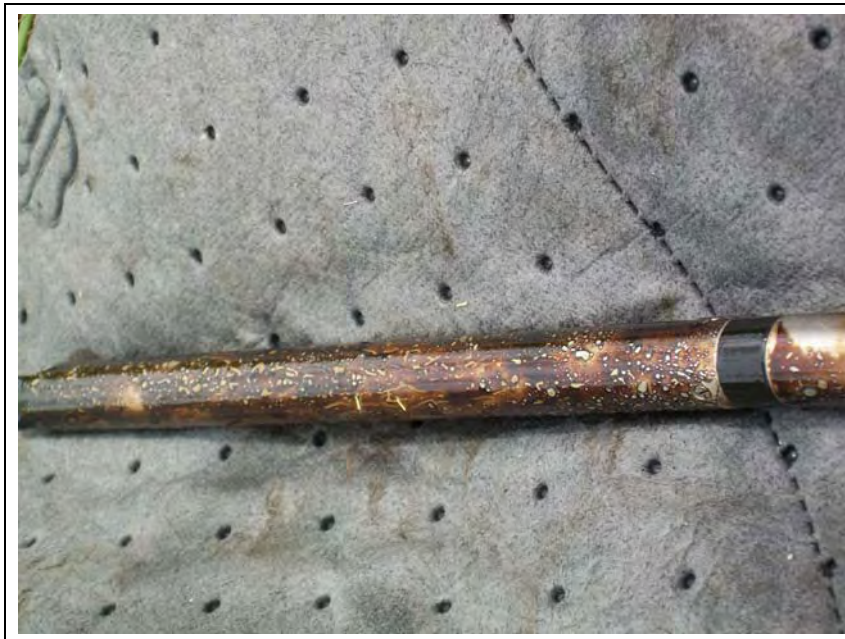
Photo 31: SWMU 8 – O/I probe tip after measurement at TLW-205.

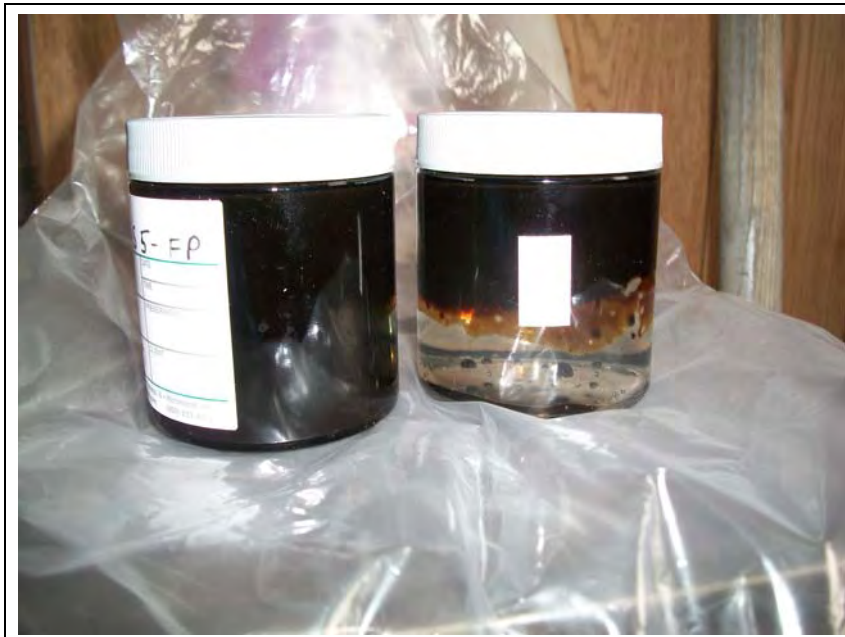
Photo 32: NAPL sample collected from T20S(5).

Additionally, a confirmatory NAPL sample was collected from T20S(5) and analyzed for specific gravity and viscosity. This location was selected for a sample as the visible characteristics of the NAPL appeared different from those noted during the RFI. Sample results from T20S(5) are summarized on Table 4a. Viscosity results are similar between the two sampling events. For reference, similar measurements collected during the RFI are also provided Table 4b.
